# **The Great Tangshan Earthquake of 1976**

**Overview Volume**

Earthquake Engineering Laboratory  
California Institute of Technology  
Pasadena, California 91125  
2002

# **An Introduction and Historical Summary of the Tangshan Earthquake**

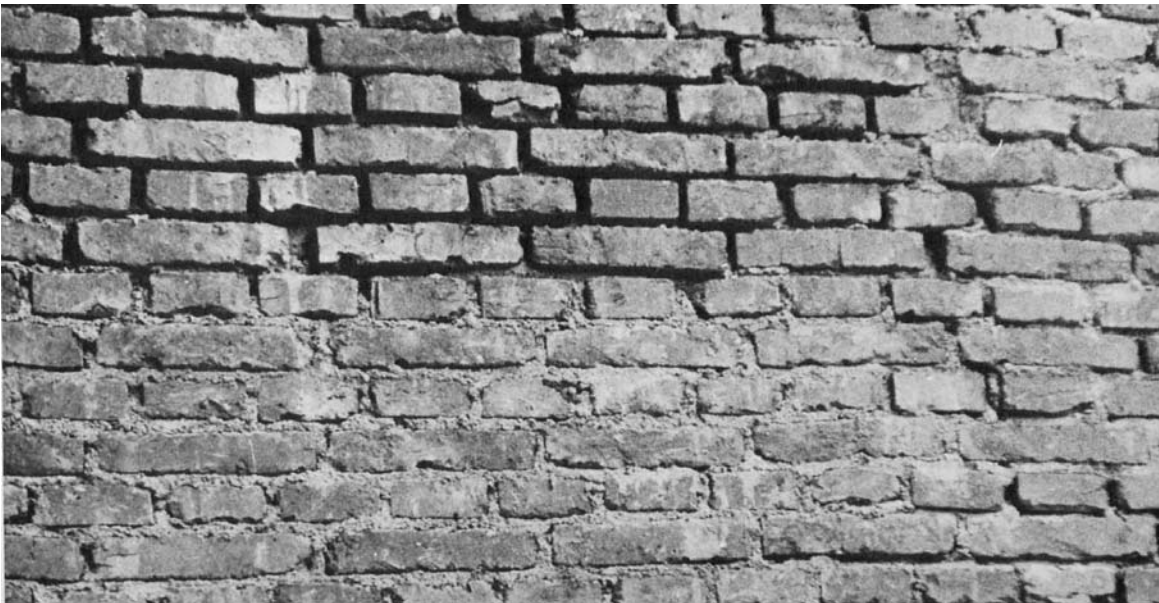
The quality of the brickwork in the building was quite poor by U.S. standards. This appeared typical of masonry construction seen in China at that time. The brick was often soft and the mortar very weak, normally, it could be broken with one's fingers. Head joints were rarely filled, and even the bed joints often have large gaps.

Figure 9. Apartment building shown in Figure 8. At lower left, joints are filled. In the upper portion, head joints are open, and bed joints only partially filled.

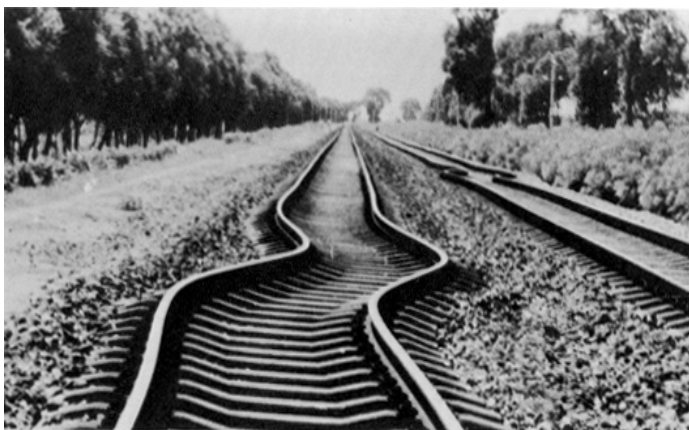
Figure 21. Buckling of rail lines due to ground deformations. The general Tangshan region had many soft soils that behaved poorly during the earthquake.

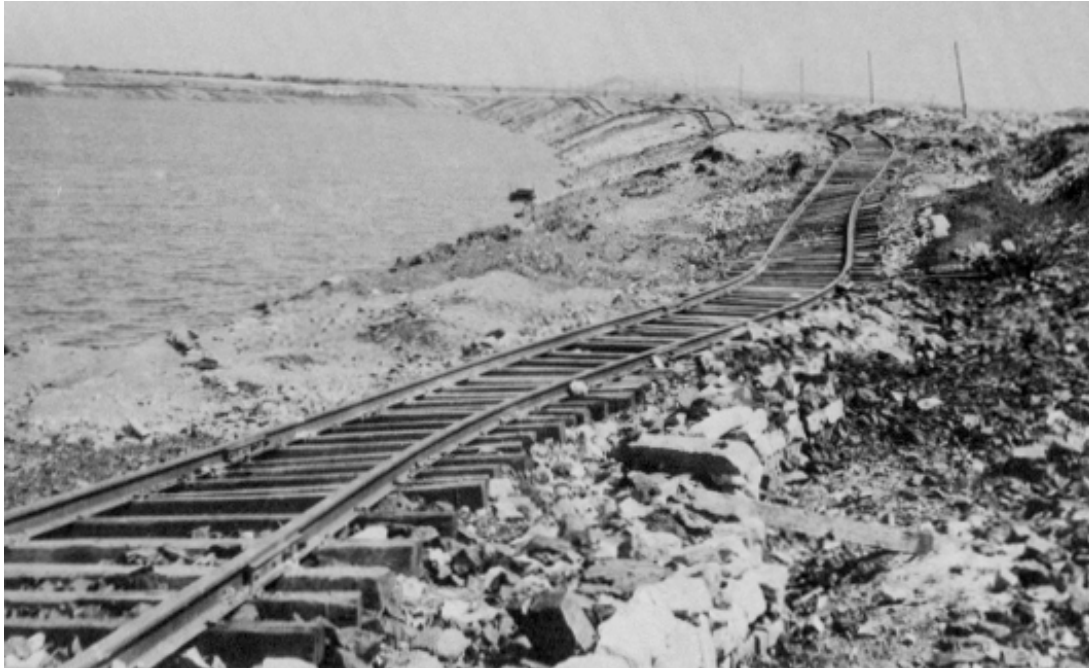
Figure 22. Failure of ground under railway line. Extensive damage was done to the rail system in the Tangshan region.

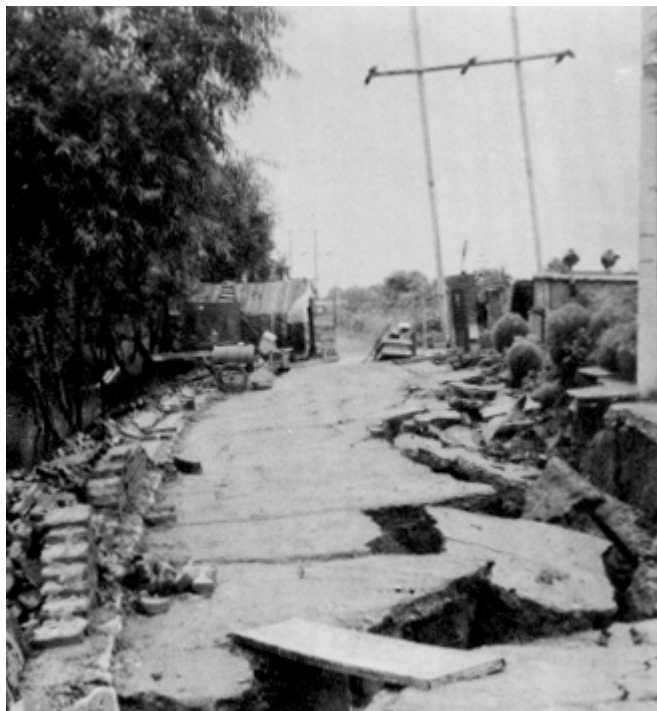
Figure 23. Damage to road near Loting Hsien. Slumping, lurching and settlement of soft soils caused extensive damage to highways in the Tangshan region.

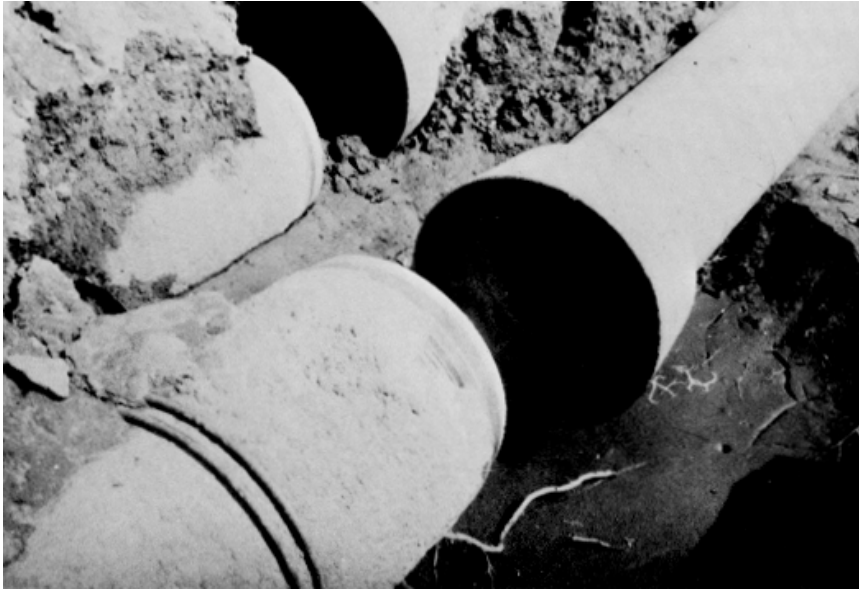
Figure 24.  
Underground pipes  
separated by  
extensional ground  
deformation.

Damage to the main underground water supply lines was worse in soft ground than in firm ground, as shown in Table 2. These water mains and supply trunk lines were either concrete pipe or cast iron pipe, with diameters up to 300 mm. The water supply system of Tangshan was totally disrupted, and several months were required to restore service; the water supply lines of Tianjin were also disrupted, presumably because of very soft soils. A visitor to Tianjin 2 years after the earthquake reported that fire hose was still being used for water mains in some parts of the city.

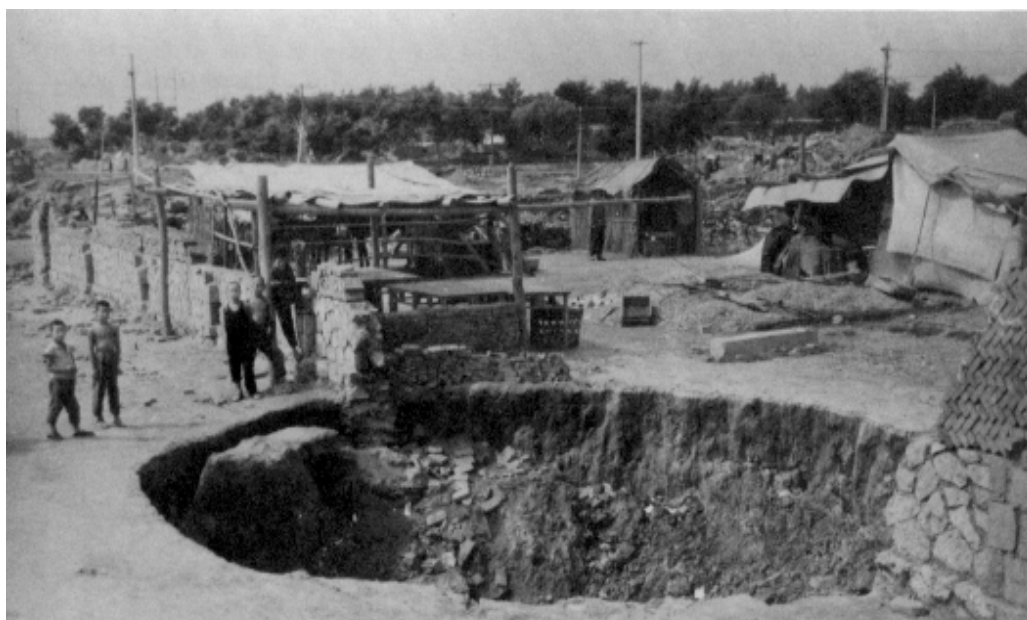
Figure 25. Ground collapse near Tachuangtuo Commune, Kuyeh Hsien. The Tangshan earthquake triggered the formation of a number of such craters. Geological investigations had not yet determined the underlying cause of these craters.

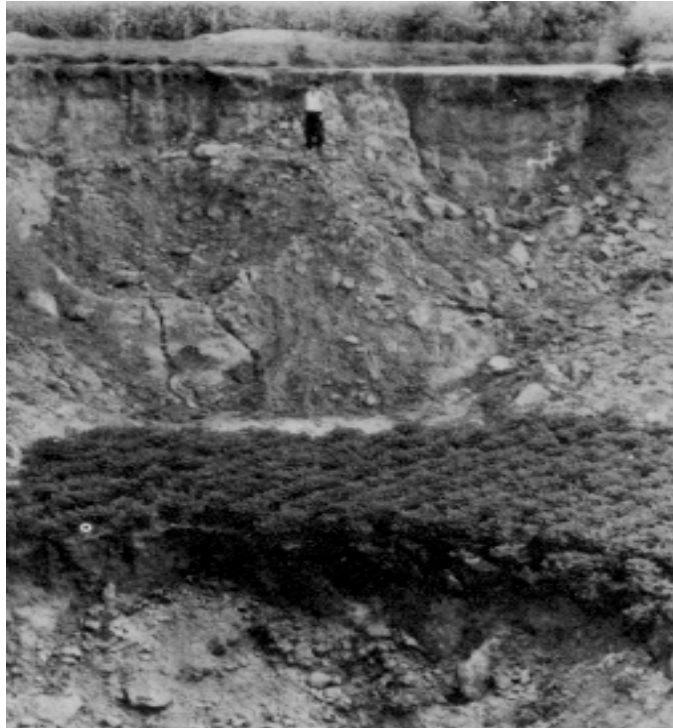
Figure 26. View of the interior of a very large crater formed near Hsiaotun, Chengchaungze Commune, north of Tangshan.

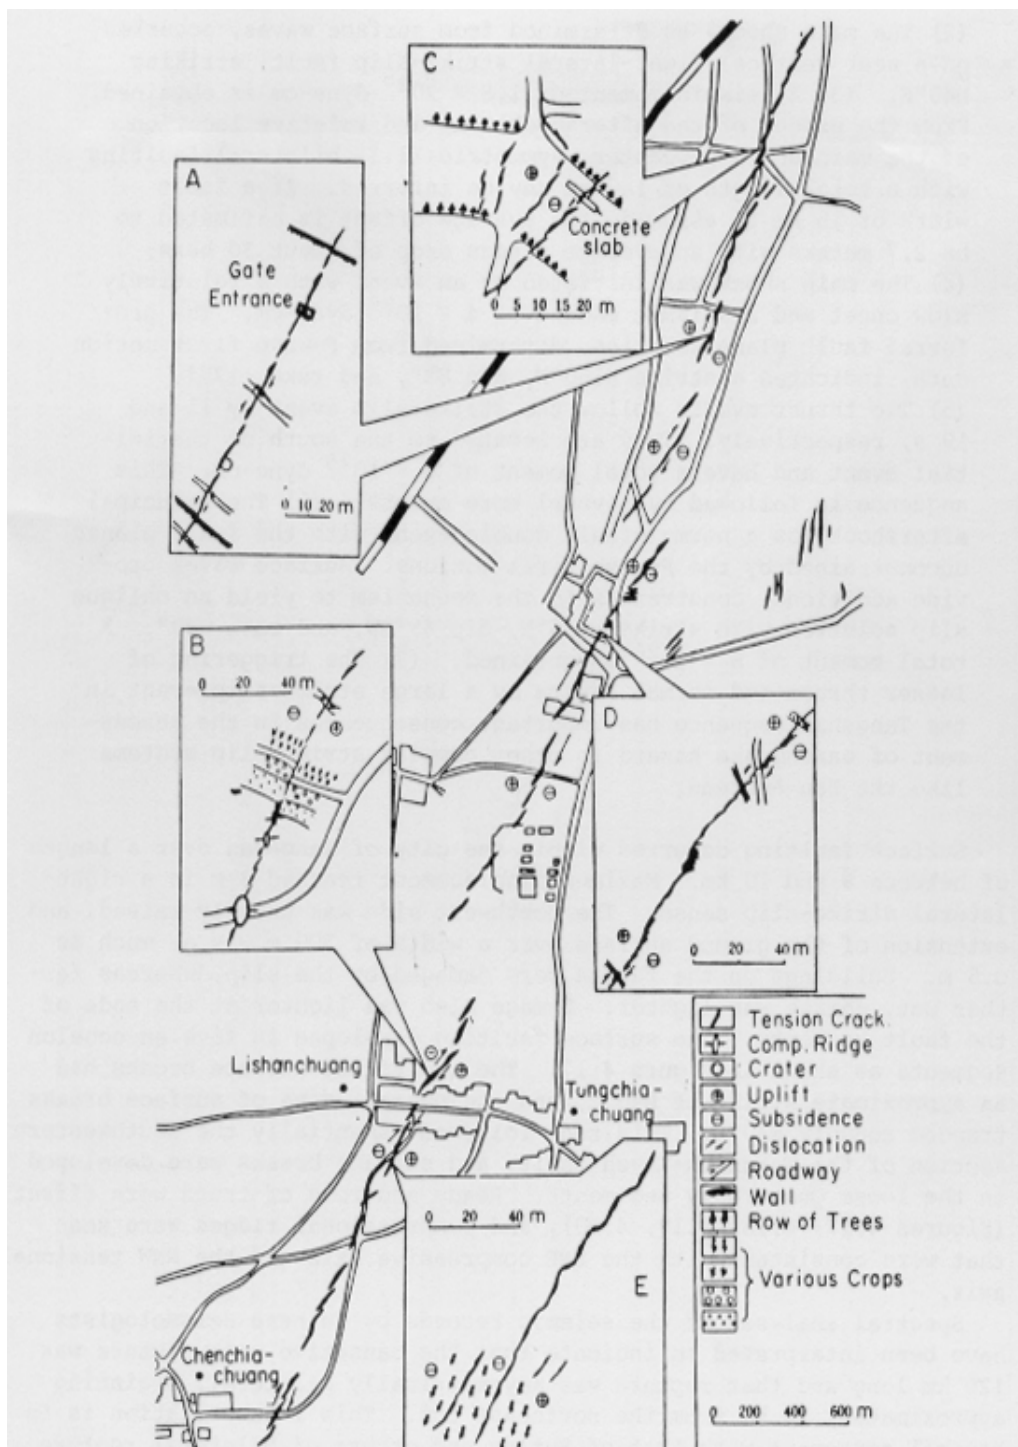
Surface faulting occurred within the city of Tangshan over a length of between 8 and 10 km. Maximum displacement reached 3 m in a right-lateral strike-slip sense. The northwest side was usually raised, and extension of the ground surface over a width of 300 m was as much as 0.5 m. Buildings on the faults were damaged by the slip, whereas farther out, damage was lighter. Damage also was lighter at the ends of the fault segments. The surface faulting developed in five *en echelon* segments as shown in Figure 35. The individual surface breaks had an approximate strike of N40°E, and the overall zone of surface breaks trended roughly N30°E. This zone followed essentially the southwestern section of the Tangshan-Kuyeh fault, and surface breaks were developed in the loose Quaternary sediments. Roads and rows of trees were offset (Figures 35, 36, 37, 38), and compressional ridges were seen that were consistent with the ENE compressive axis and the NNW tensional axis.

Figure 35. Surface faulting observed in the city of Tangshan.

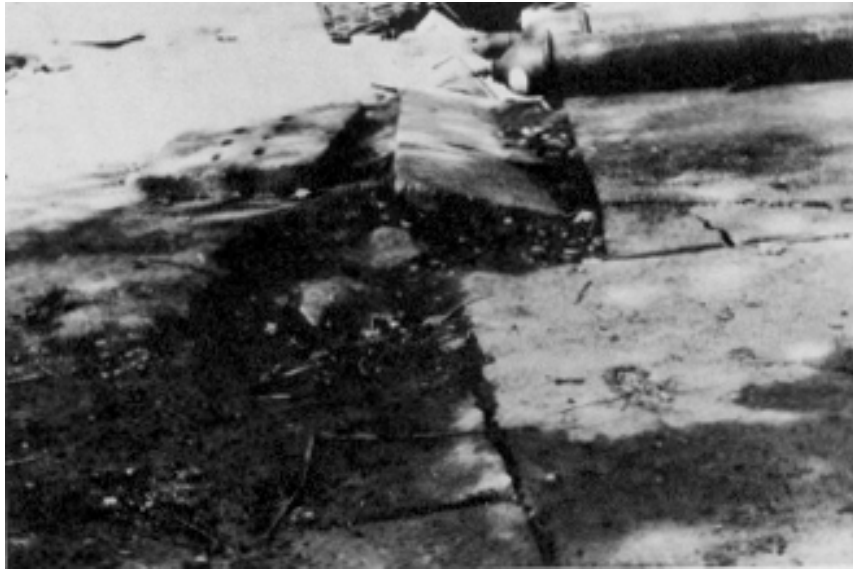
Figure 36. Surface breaks and compressed pavement over drainage trench in Tangshan

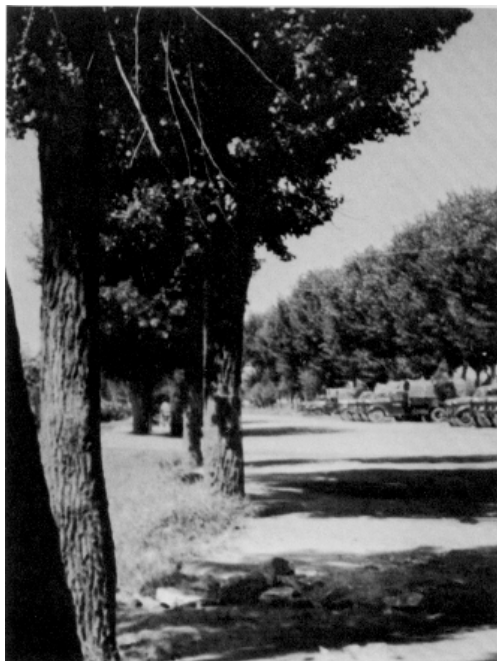
Figure 38. Offset in row of tree due to horizontal tectonic movement, in Tangshan.

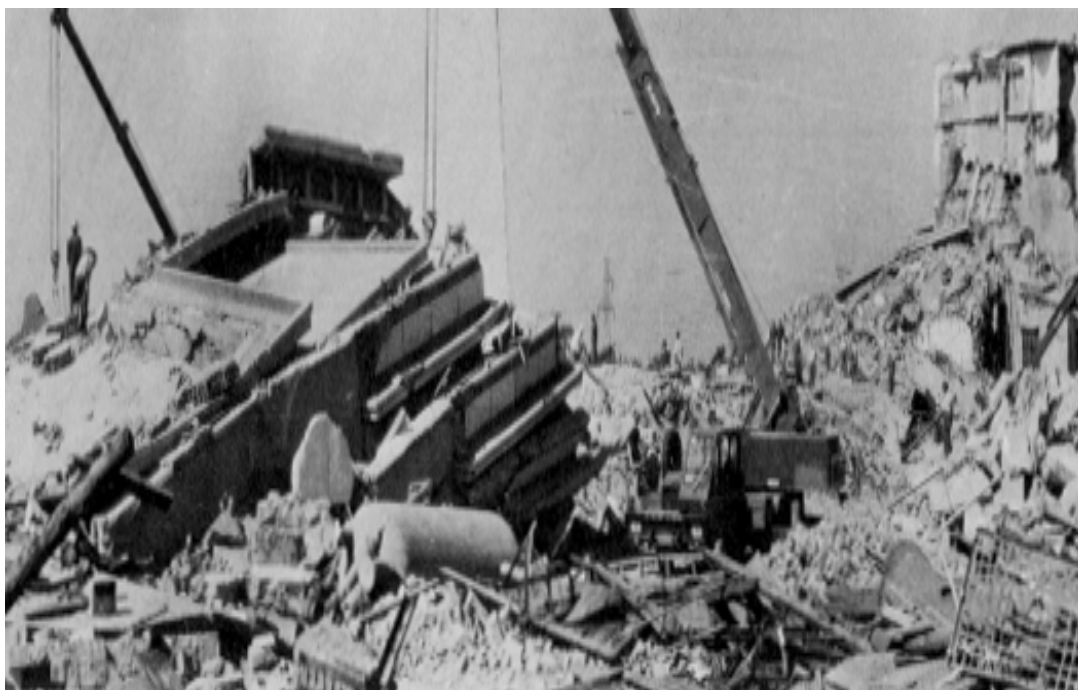
Figure 42. Collapsed out-patient service building of the Kailuan coal mine general hospital, Tangshan.

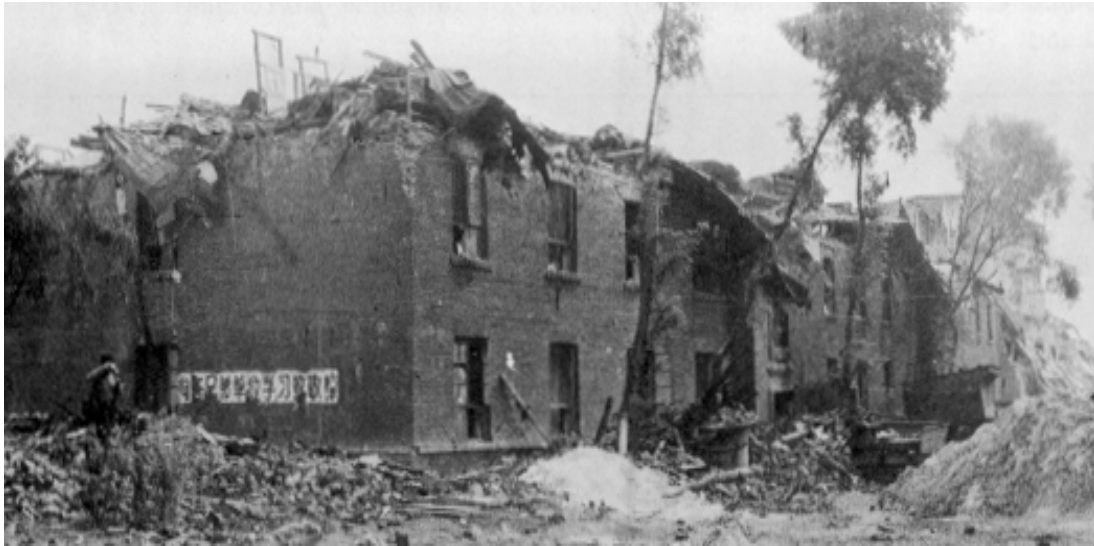
Figure 43. Collapsed top story of the three-story Kailuan coal mine dormitory, Tangshan.

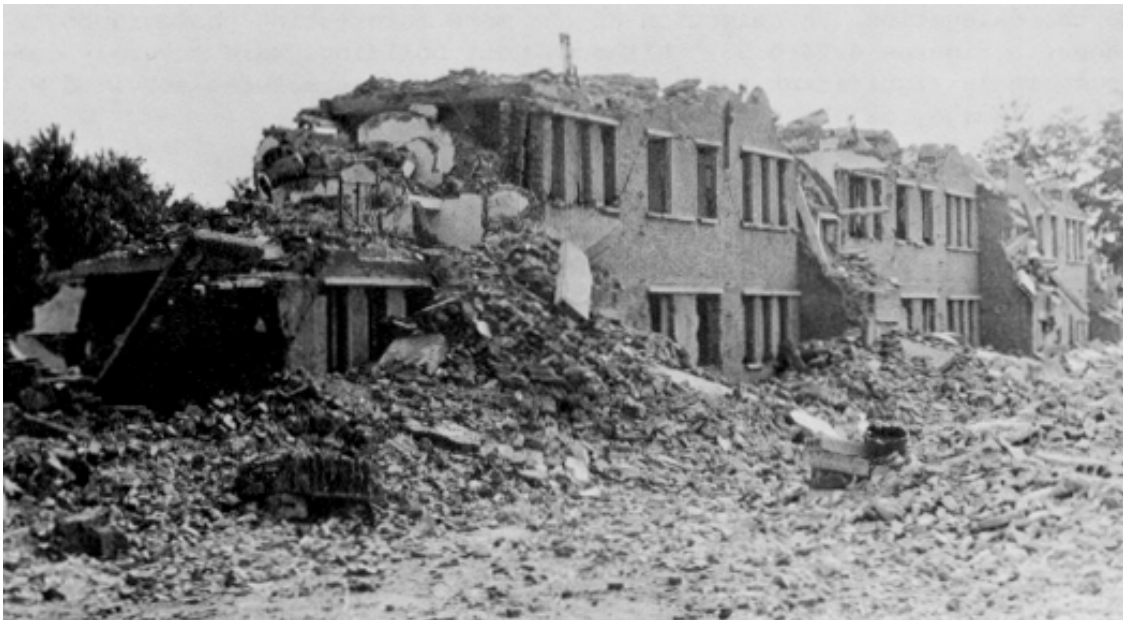
Figure 44. Collapsed four-story Tangshan Mine-Metal Institute residence building.

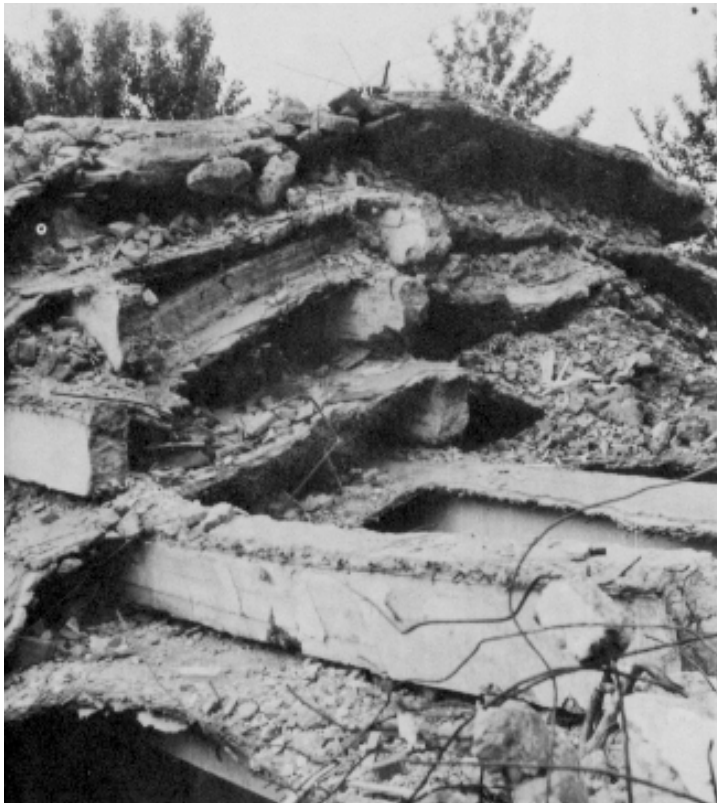
Figure 45. Collapsed five-story physics-chemistry building of the Tangshan Mine-Metal Institute.

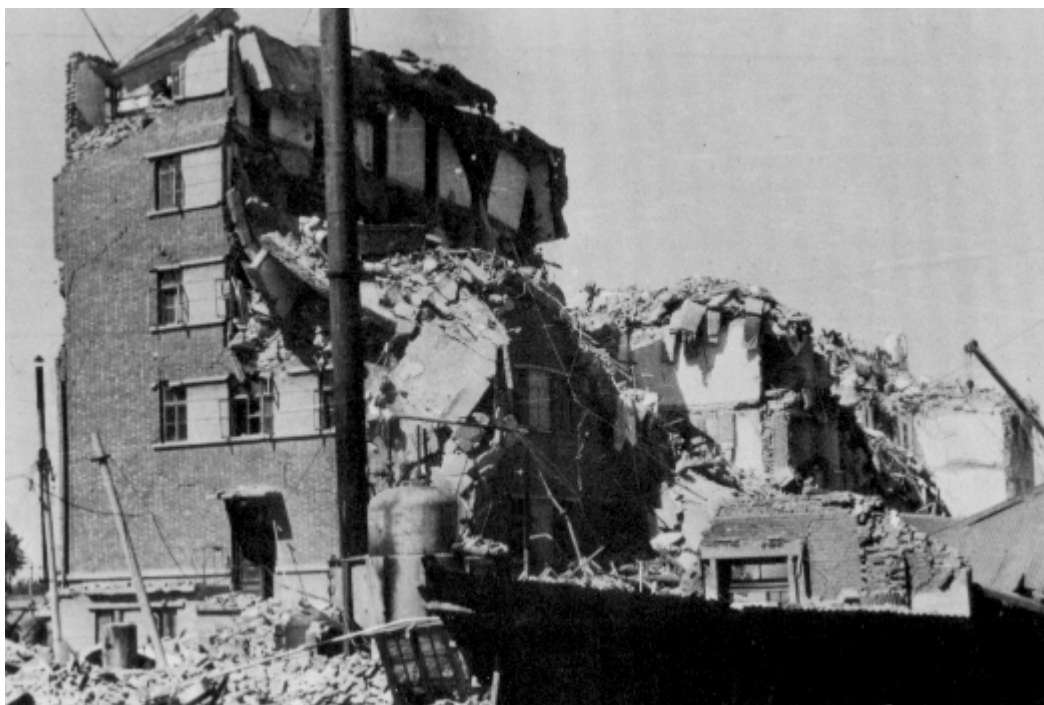
Figure 46. Collapse of Kailuan coal mine reception building, Tangshan.

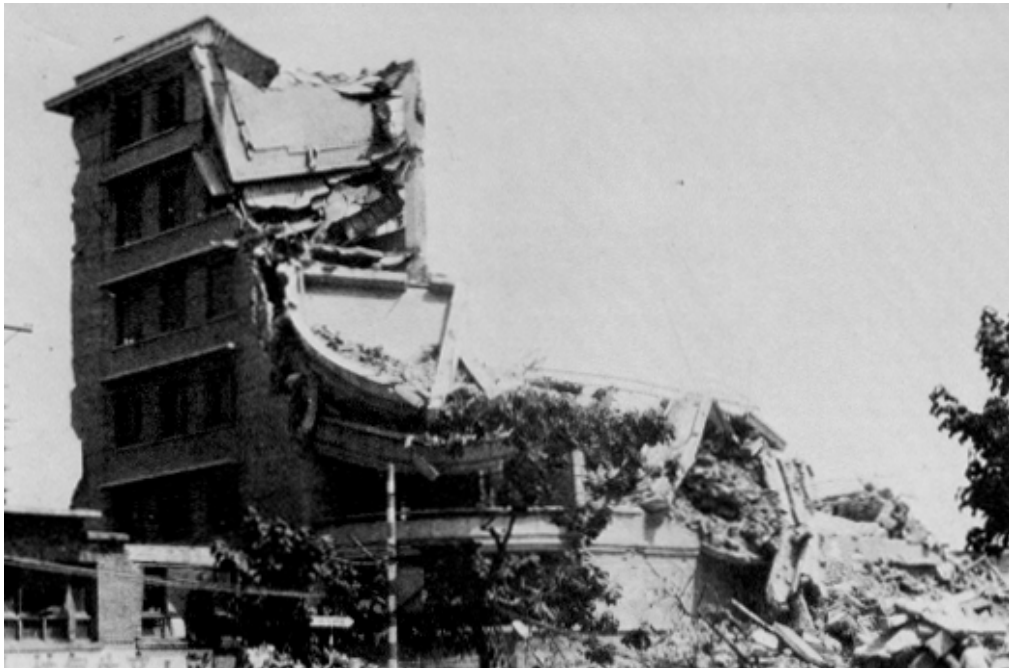
Figure 48. Collapse of six-story building at the Kailuan coal mine hospital, Tangshan.

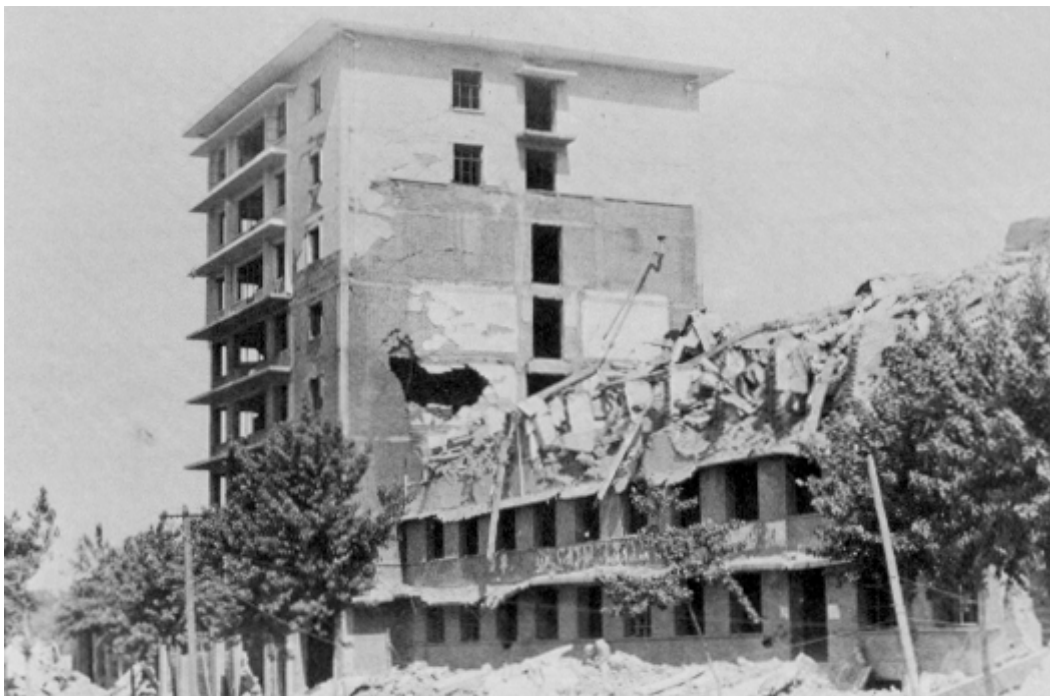
Figure 50. Eight-story Hsinhua Hotel in Tangshan was badly damaged at the fifth-story level but remained standing. In the foreground is a collapsed six-story building.

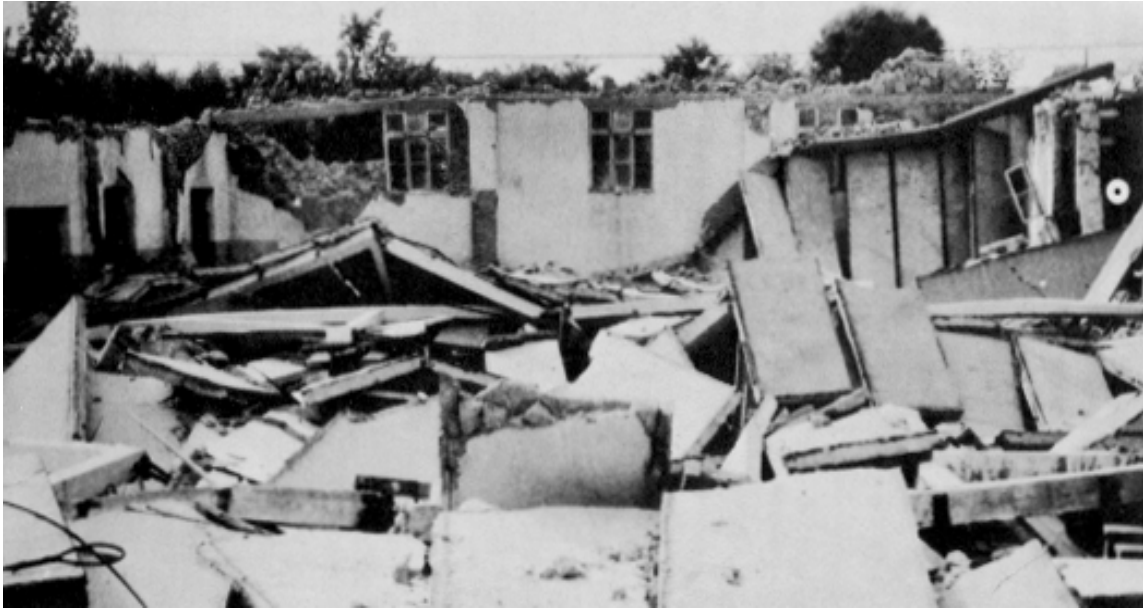
Figure 51. Collapsed workers' cafeteria building of the Chinkechuang coal mine.

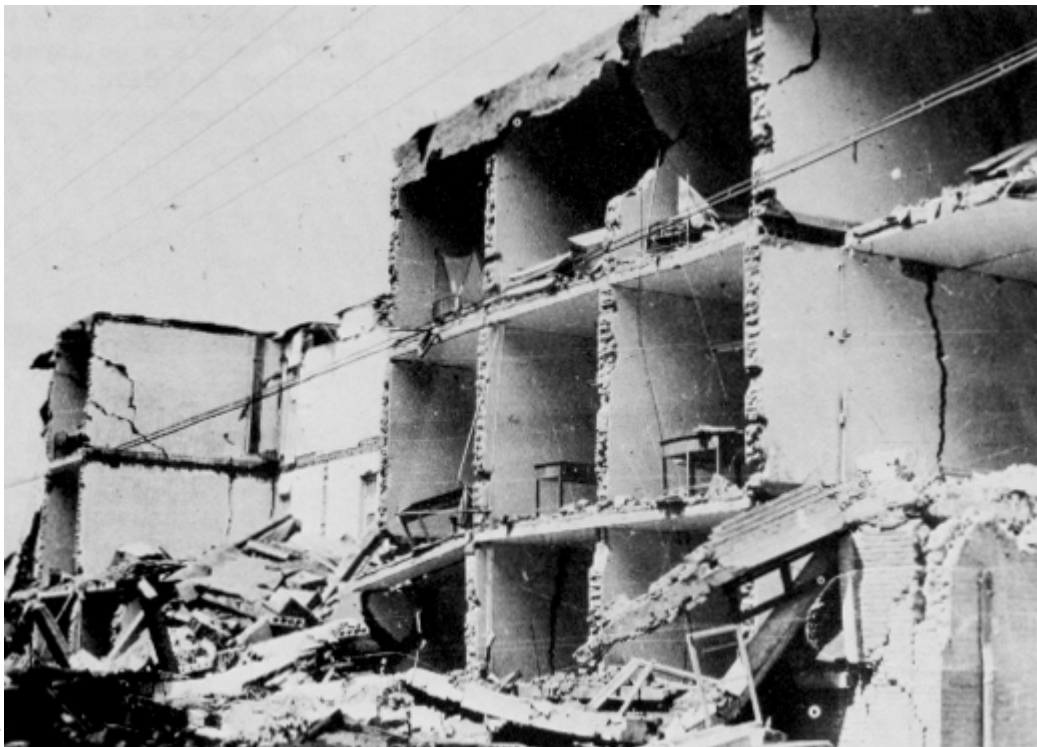
Figure 52. Partly collapsed residence building showing the type of construction: unreinforced brick bearing walls and precast concrete floor beams.

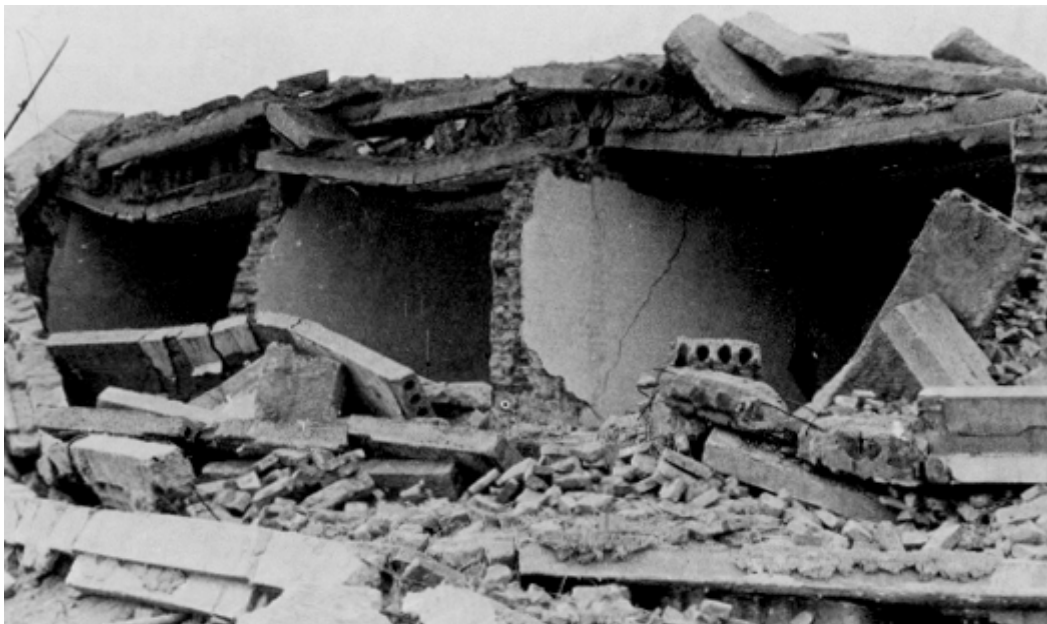
Figure 53. Collapsed building showing the type of construction: precast concrete floor slabs made of four-hole beams, simply supported on bearing walls.

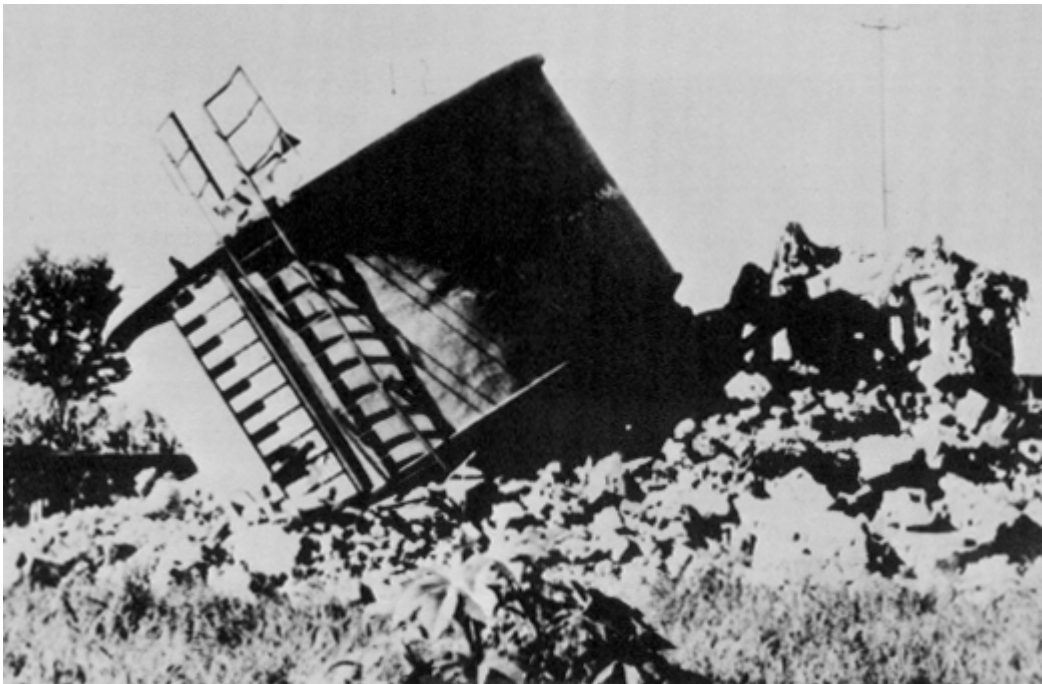
Figure 56. Collapsed elevated storage tank that had been supported on a brick cylindrical tower, Tangshan scale factory.

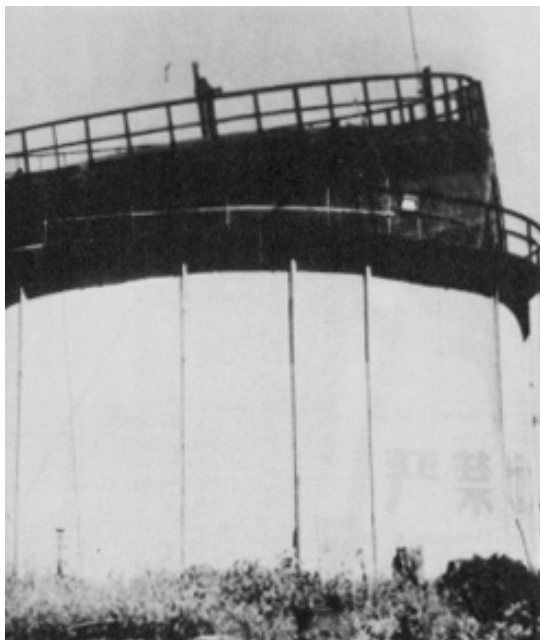
Figure 57. Damaged gas holder at Tangshan fertilizer factory.

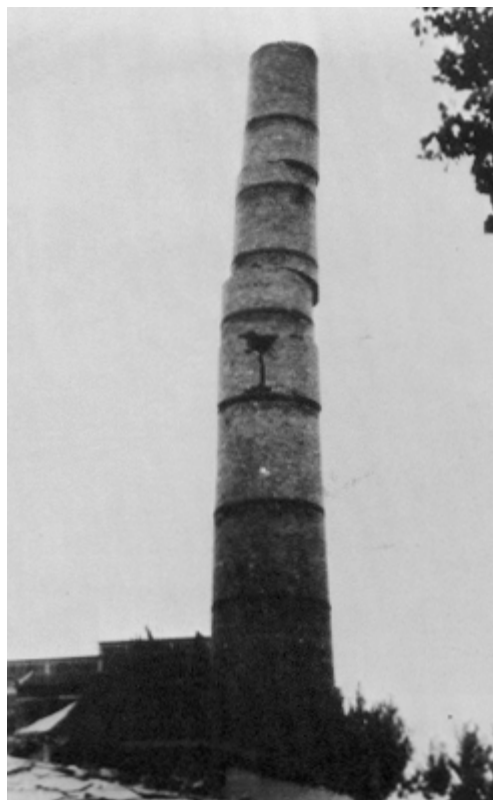
Figure 58. Damaged brick chimney at Chaokenchuang mine. The top of the chimney fell off, and four horizontal cracks appeared in the remaining portion.

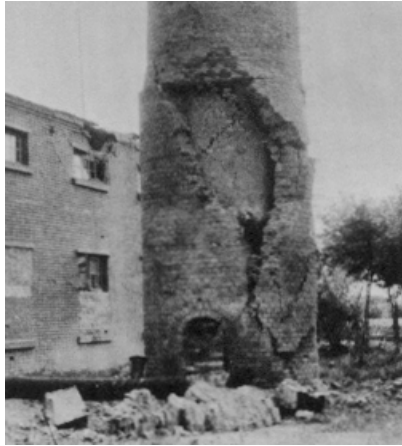
Figure 59. Damaged brick chimney.

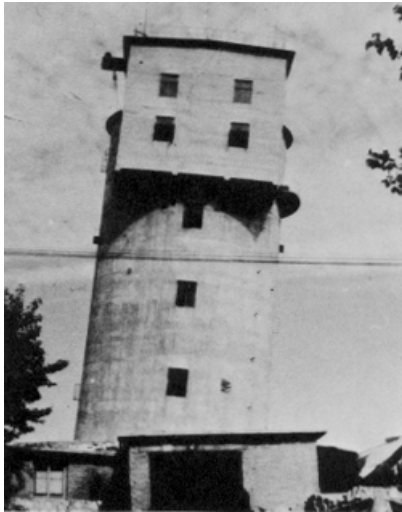
Figure 60. Tilted ventilation tower at Tangshan coal mine.

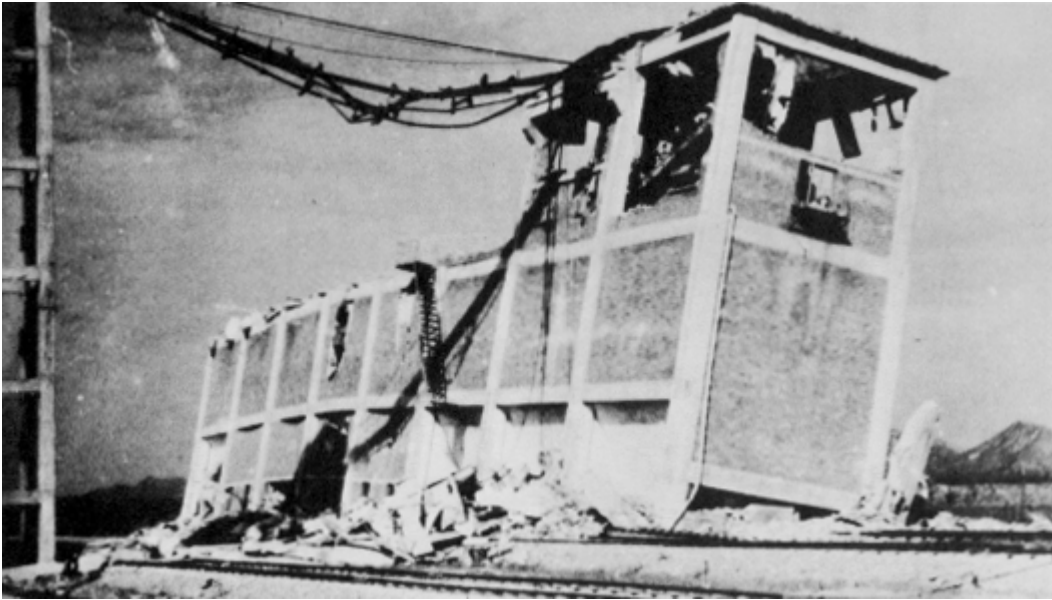
Figure 62. Collapsed coal storage structure at Chinkechuang.

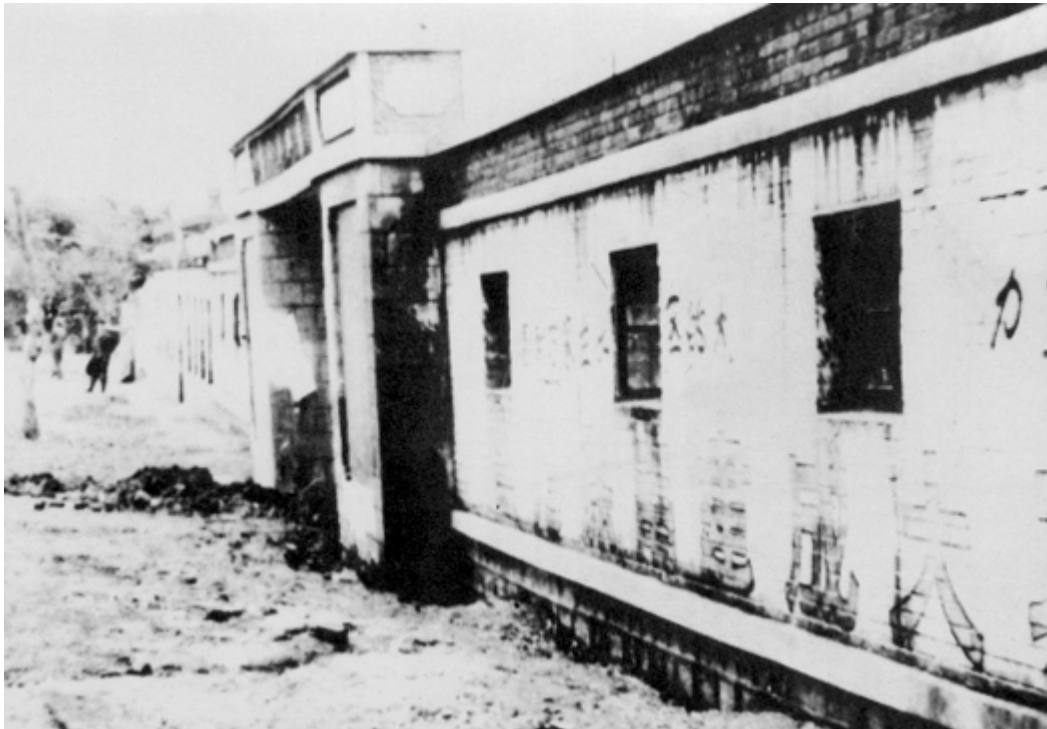
Figure 65. Uneven settlement of office building, Fankenchuang Commune, Luan-nan hsien.

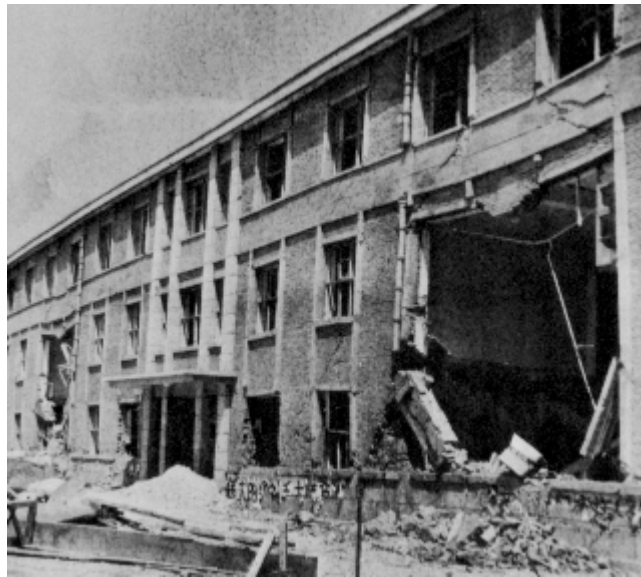
Figure 66. Damaged building at Kailuan coal mine general hospital in Tangshan.

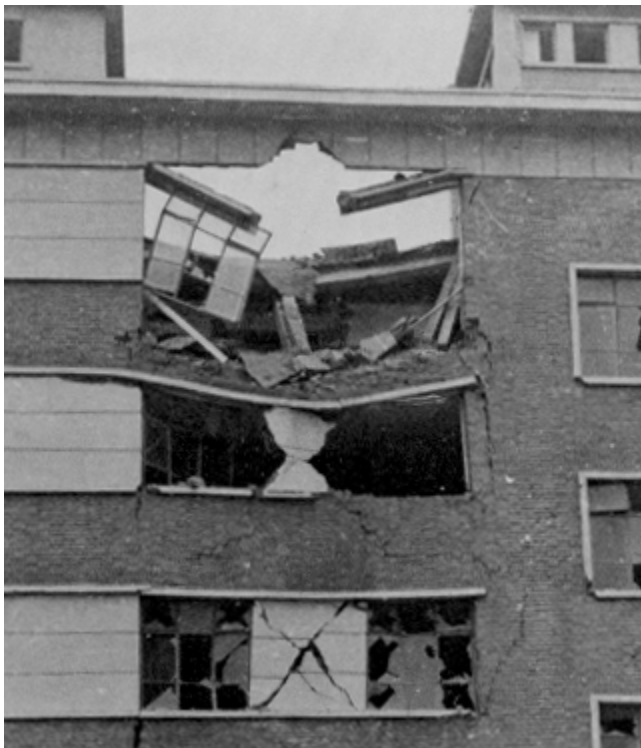
Figure 67. Damaged reception building in Tangshan.

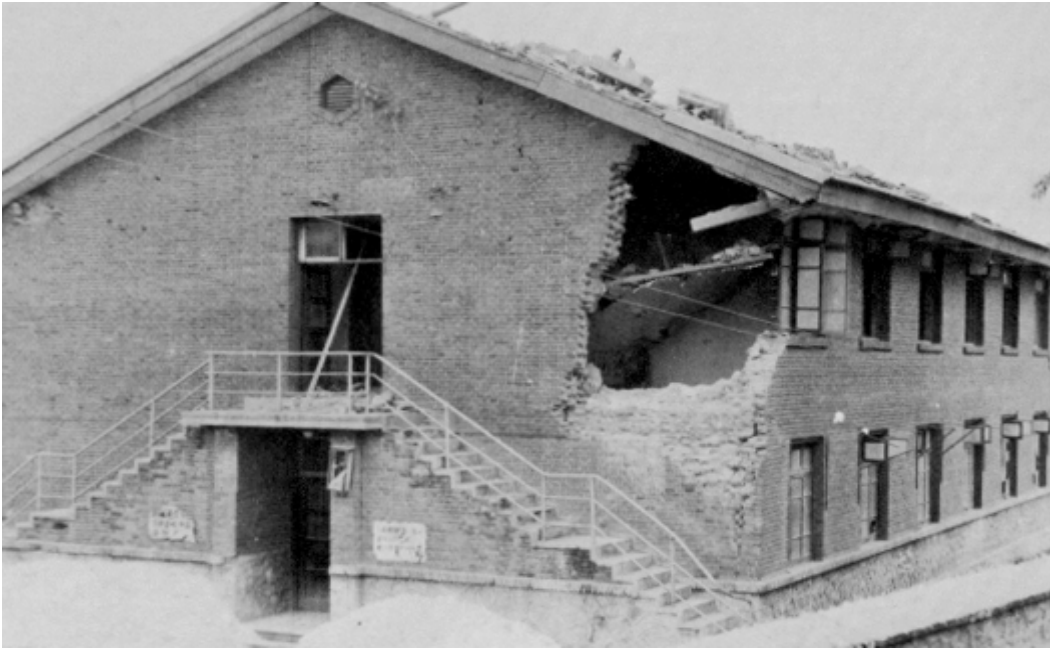
Figure 68. Damaged Tangshan second reception building. Although damaged, this two-story brick building remained standing.

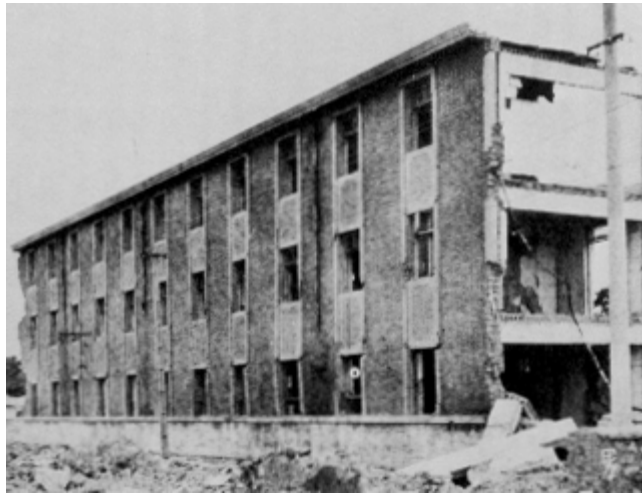
Figure 69. Damaged car factory dormitory building in Tangshan. The first story was most severely damaged but the building remained standing.

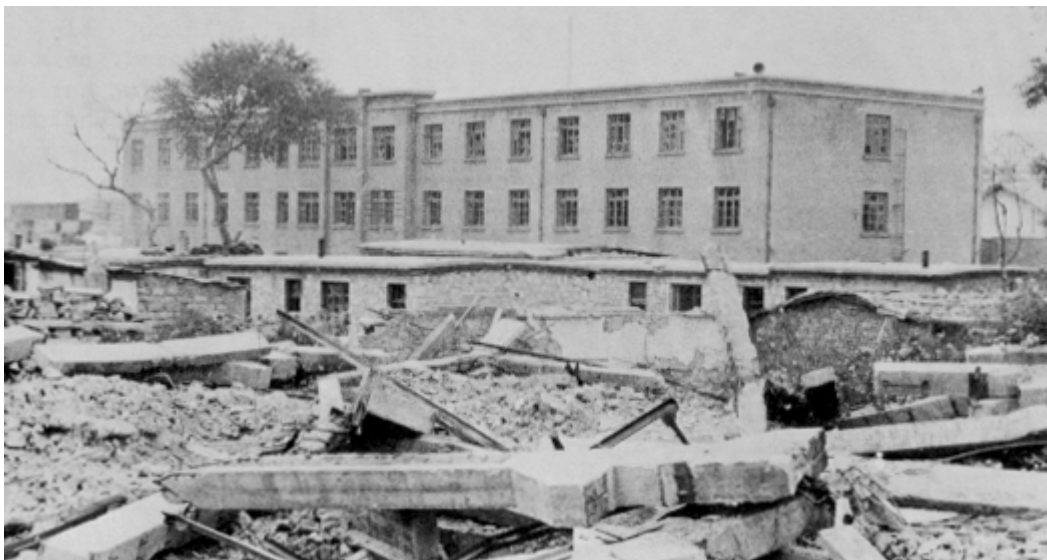
Figure 70. Tangshan light-machine plant official building. This structure, which was located in district 13 of Figure 39, was only slightly damaged. The remains of a collapsed building can be seen in the foreground.

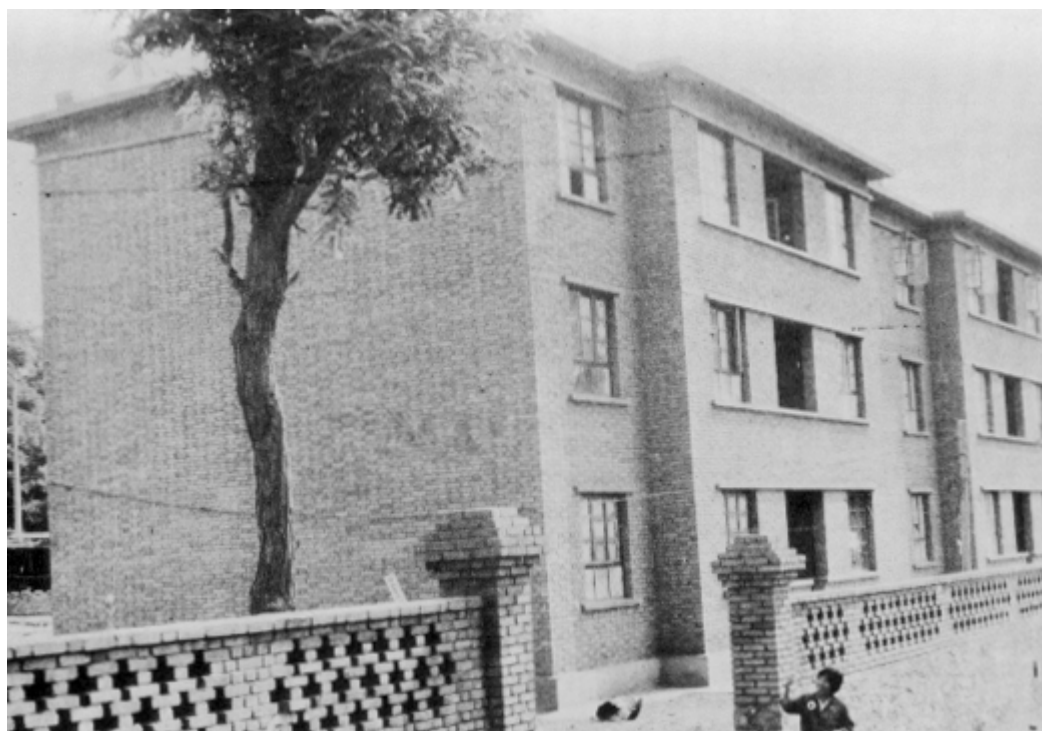
Figure 71. Cement factory worker apartment building 422. This structure was located on bedrock north of Tangshan and received only slight damage.

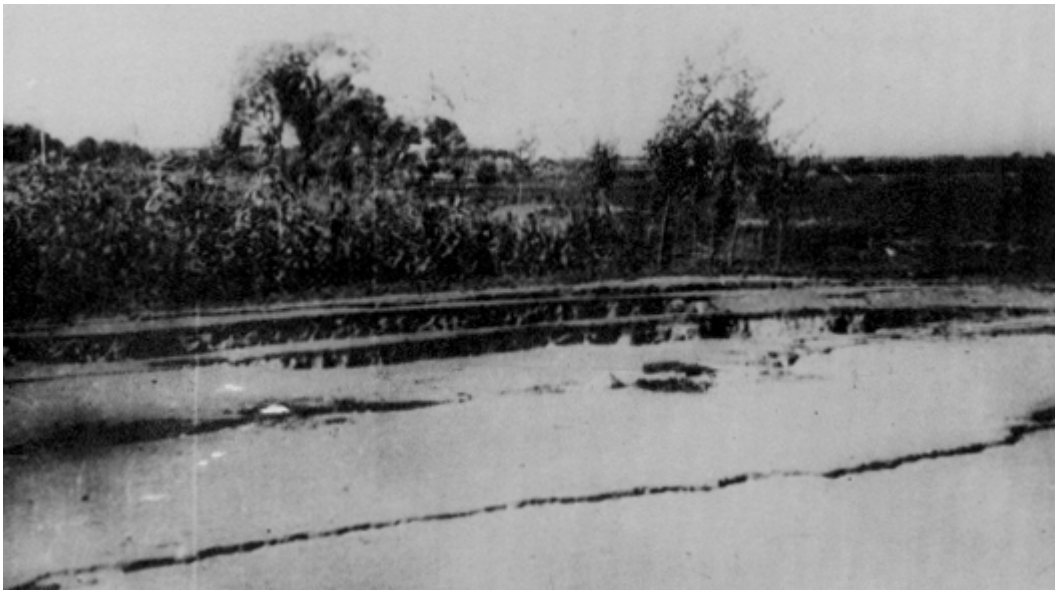
Figure 72. Large landslide at east bank of Tanshan River, which caused damage to the Yen Chuang Bridge.

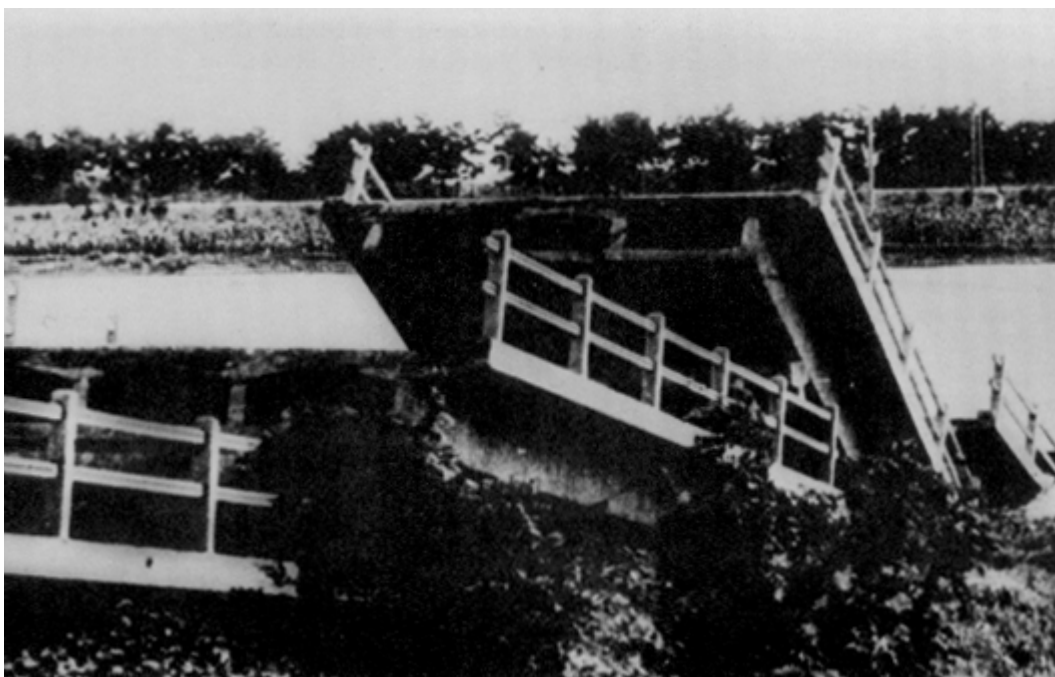
Figure 73. Deck spans of Yen Chuang Bridge were pushed off their supports by the landslide.

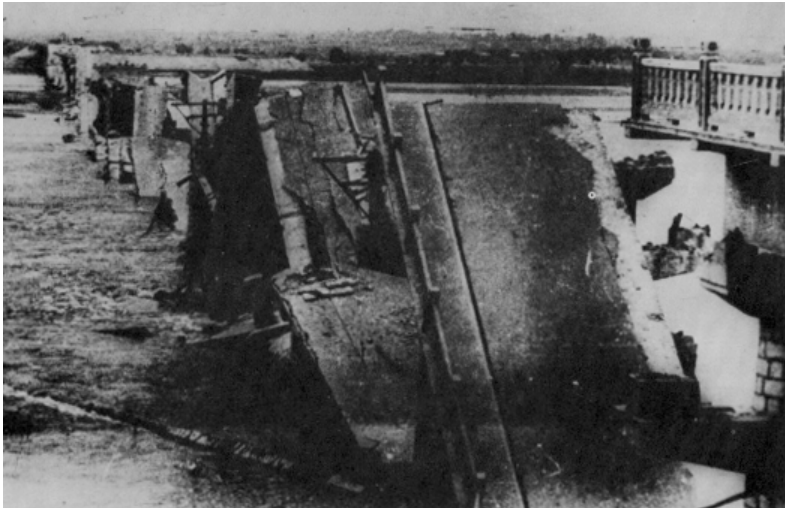
Figure 74. Fallen spans of the Janshan Bridge.

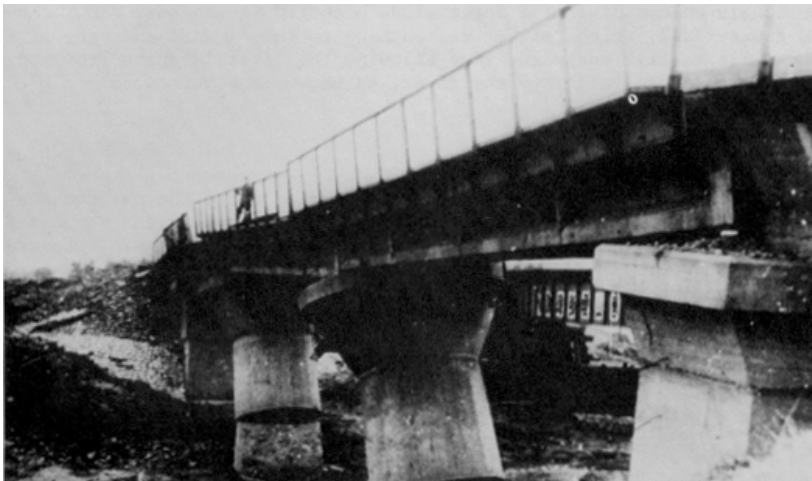
Figure 75. Tilted piers and broken abutment of the railway bridge on Tangshan-Kenhua Line.
