# **The Great Tangshan Earthquake of 1976**

**Overview Volume**

Earthquake Engineering Laboratory  
California Institute of Technology  
Pasadena, California 91125  
2002

# **An Introduction and Historical Summary of the Tangshan Earthquake**

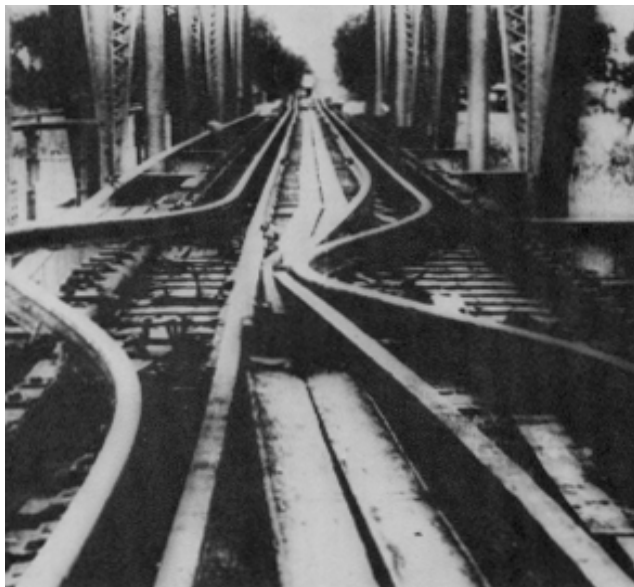
Figure 76. Buckled steel rails on railway bridge on Peking-Shanhaikuan line.

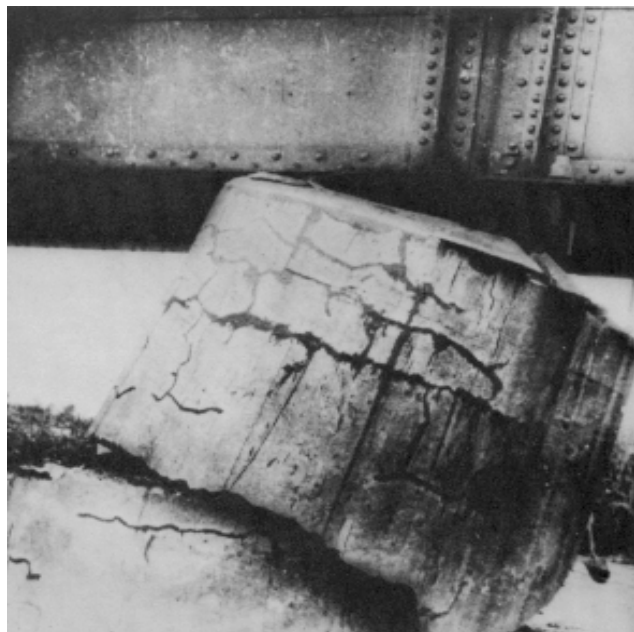
Figure 77. Broken pier of railway bridge 55 on the Peking-Shanhaikuan line.

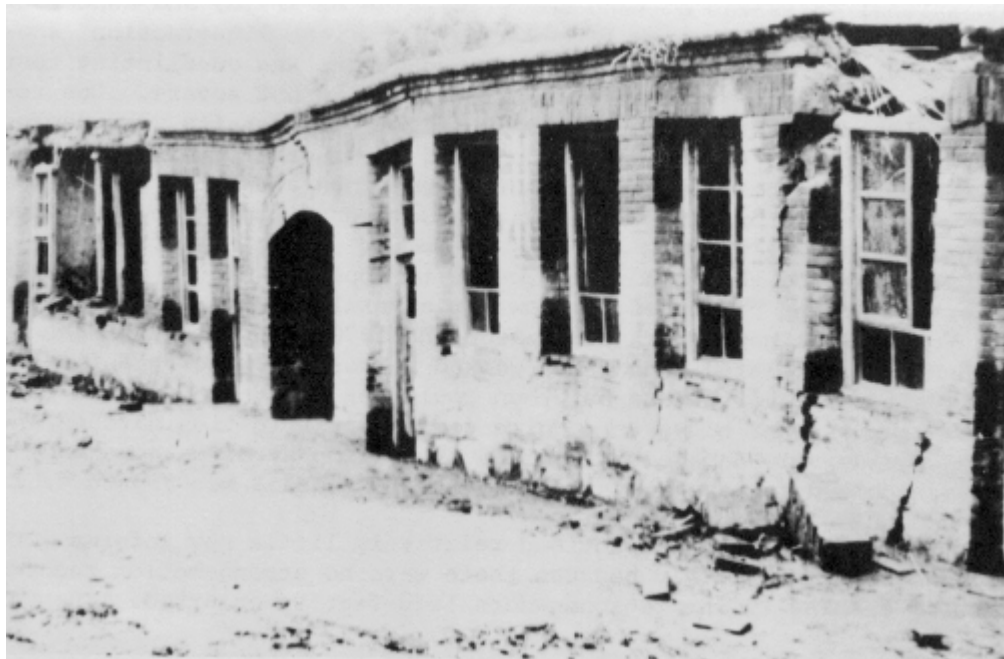
Figure 79. Structure damaged by unequal ground settlement.

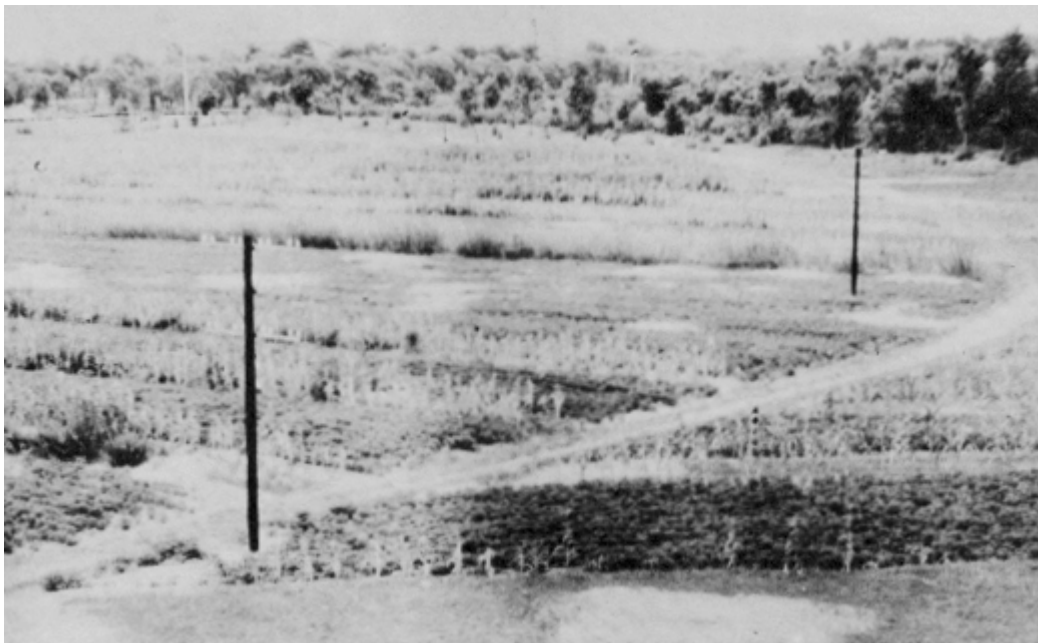
Figure 80. View of sandblows in a field.

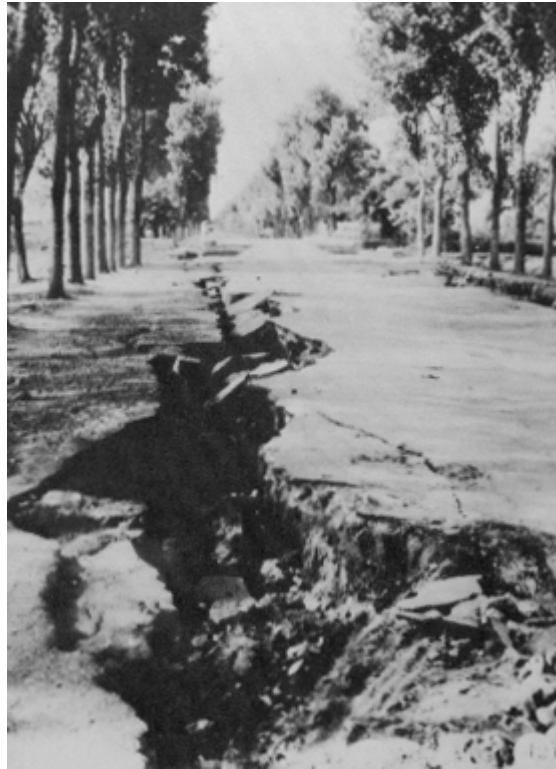
Figure 81. Damage to a road caused by soil failure.

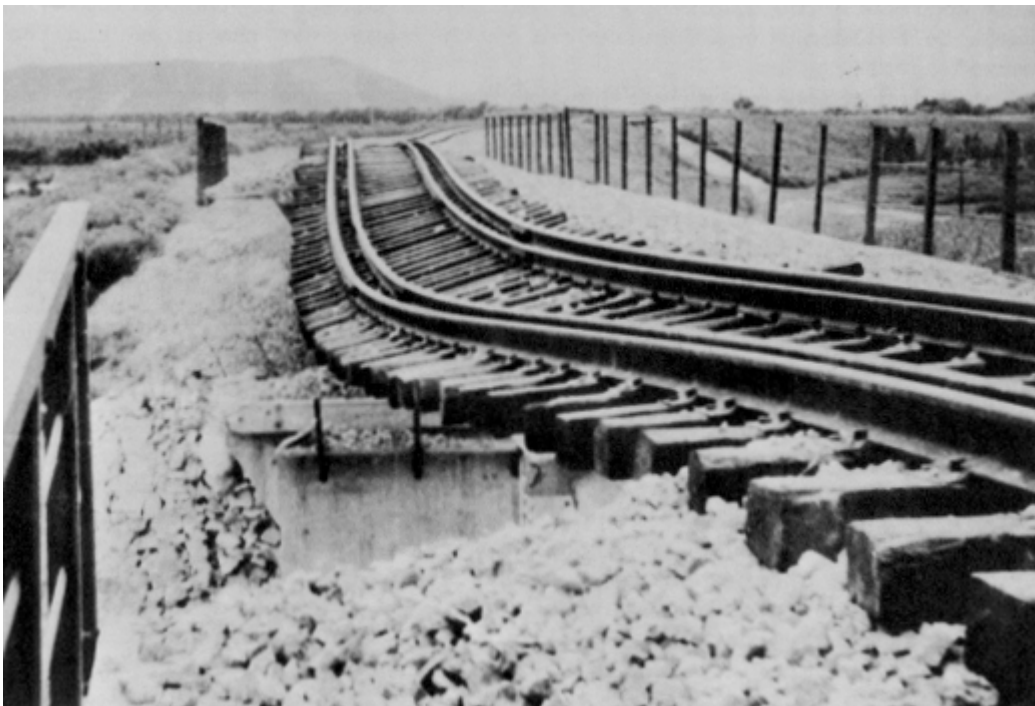
Figure 82. Damage to railway line caused by loss of support.

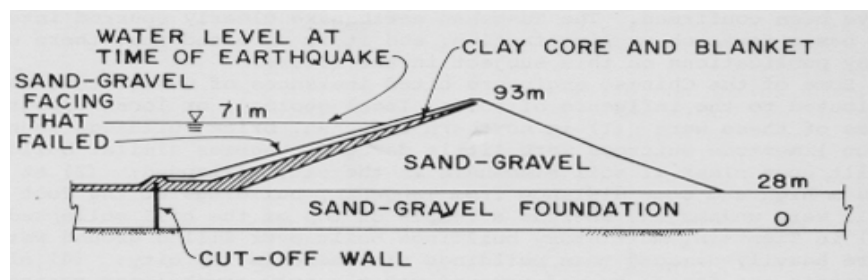
Figure 83. Cross section of Paiho main dam at Miyun Reservoir. During the earthquake the sand-gravel facing on the upstream face of the dam slumped down.

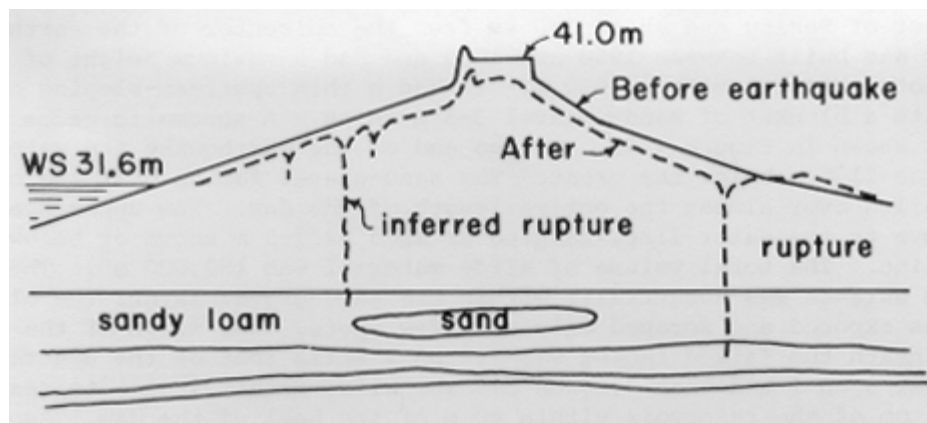
Figure 84. Sketch showing settlement of the earth dam at Touho reservoir.
