# **The Great Tangshan Earthquake of 1976**

**Overview Volume**

Earthquake Engineering Laboratory  
California Institute of Technology  
Pasadena, California 91125  
2002

# **An Introduction and Historical Summary of the Tangshan Earthquake**

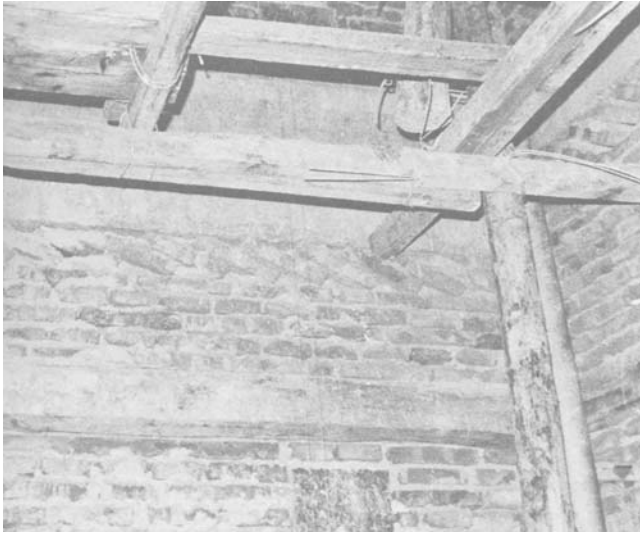
Figure 4. Interior of elevator shaft of Beijing Duck Restaurant showing brick filler walls. Note “leaning soldier” bricks at top, a method of filling space that is not a module of brick dimensions.

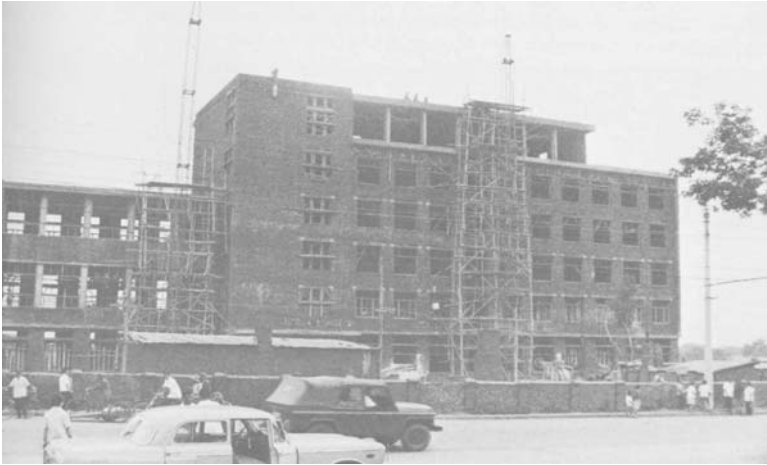
The quality of the brickwork in the building was quite poor by U.S. standards. This appeared typical of masonry construction seen in China at that time. The brick was often soft and the mortar very weak, normally, it could be broken with one's fingers. Head joints were rarely filled, and even the bed joints often have large gaps.

Figure 5. Exterior view of six-story brick walled building in Harbin. The structure was intended to house an electronics factory when completed.

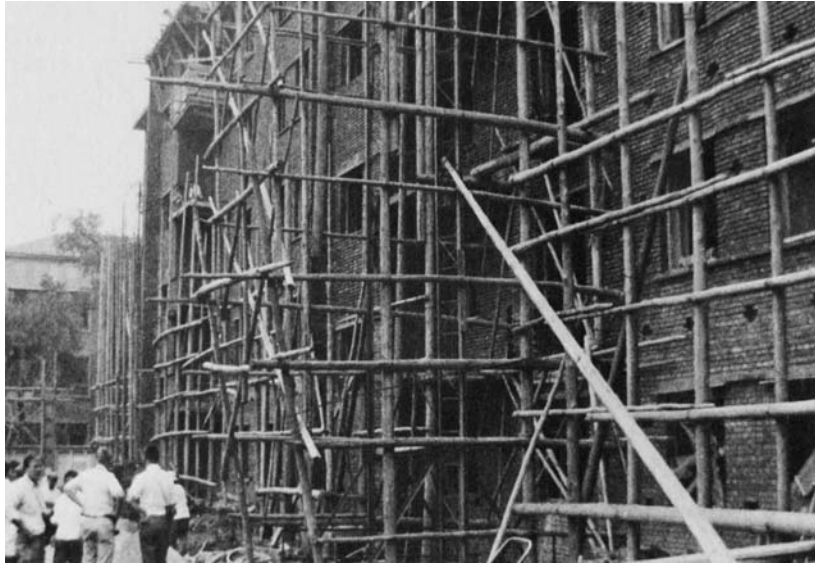
The third project was an almost complete six-story apartment house shown in Figure 8. It was a part of a large complex of about a dozen similar buildings. The construction was similar to that discussed above, namely, unreinforced brick bearing walls, precast floor units, precast stairs, etc. A portion of one of the walls is shown in Figure 9, illustrating the variability of workmanship in the construction of the wall.

Figure 8. Exterior view, taken in 1978, of a nearly complete six-story brick apartment building in Harbin.

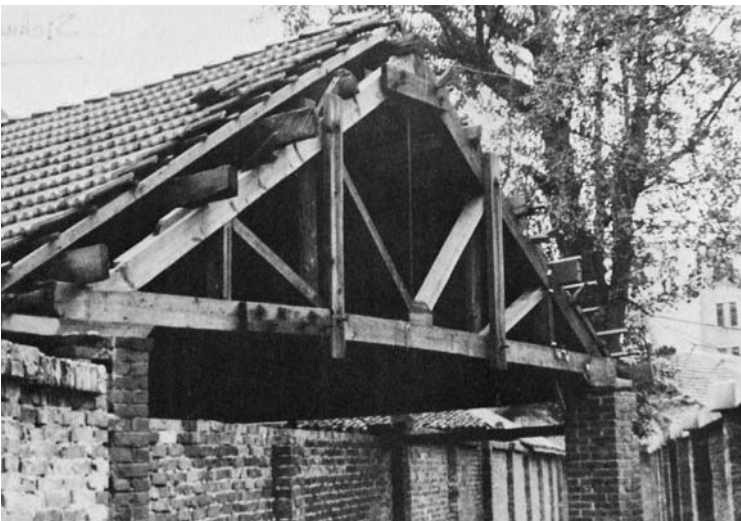
Figure 11. Timber truss on a small building in Chengdu near the apartment building of Figure 10. Note the unreinforced brick columns, which appeared to be used extensively in China.

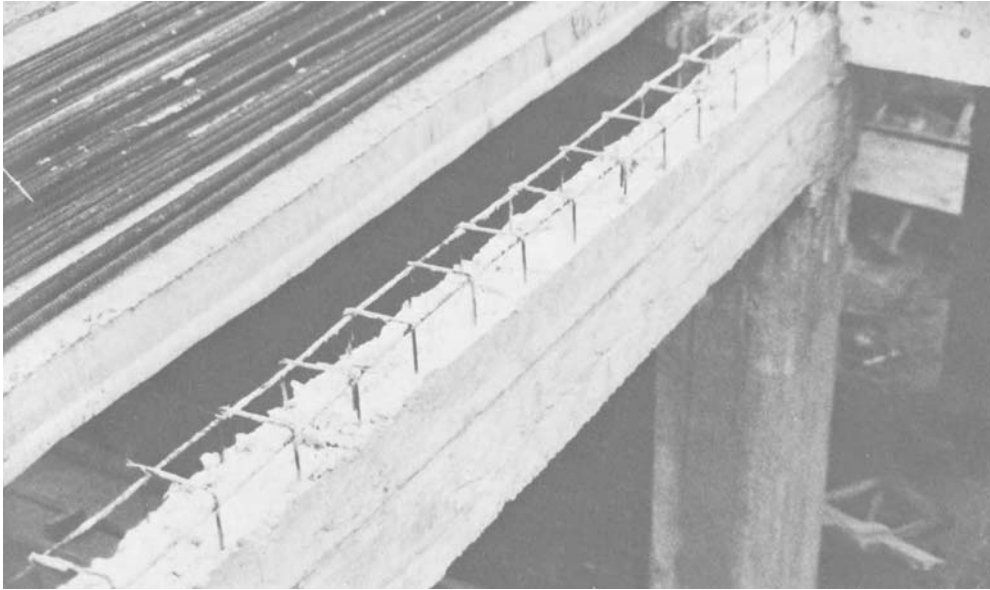
Figures 12, 13 and 14 show views of the building. The concrete frame was cast in place from the third floor up, whereas the first floor columns and some second-story columns and beams were precast. Floors were precast hollow concrete planks with a topping. When the topping was placed, stirrups (Figure 15) from the cast-in-place beam would tie the slab to the beam where the slabs are parallel to the beam, but the tie to the beam that supports the slab appeared minimal.

Figure 15. Chengdu office and storage building. In the upper stories, columns and beams were cast in place. Later, precast floor units were placed on the beams. Note ties from beam where beam is parallel to slabs.

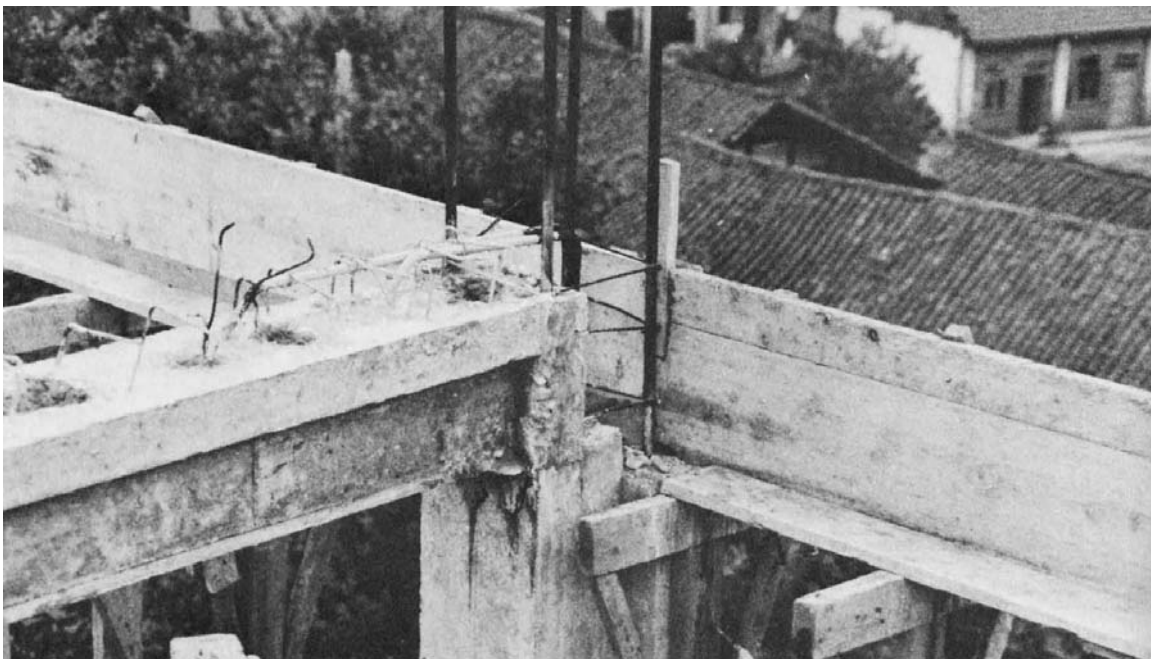
Figure 16 shows a cast-in-place column and beam and the forms for the cast-in-place spandrel beam that will be poured next. This sequence results in construction joints through the structural joint itself. There is no provision for shear in the joint, and the detailing provides for little ductility.

Figure 16. The columns and transverse beams have been cast in place in this detail of an upper floor. Forms are in place for the cast-in-place spandrel beam. The joint is integral but a construction joint goes through the center.

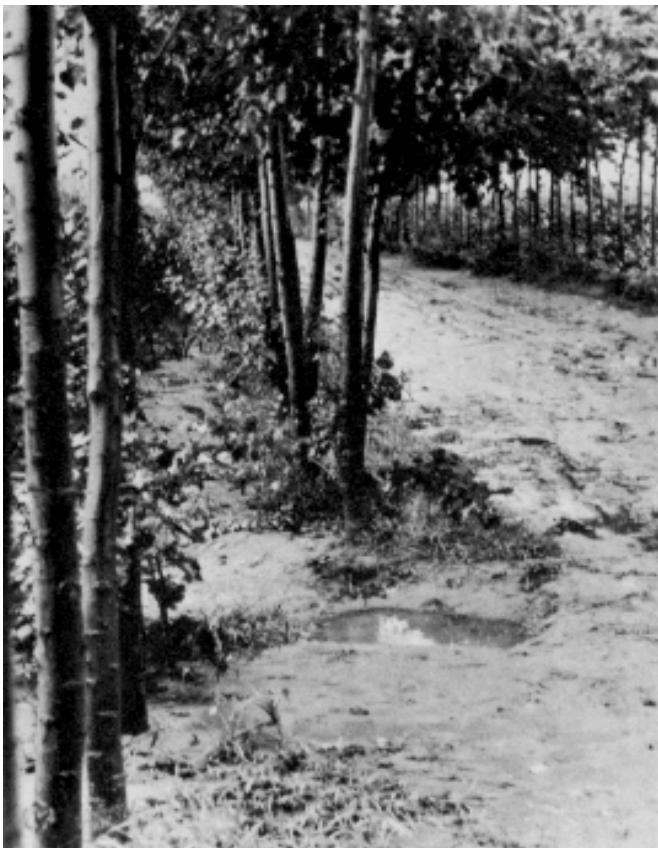
Figure 37. Offset in row of young trees by surface break near Laoting Hsien (direction N40°W, maximum displacement, 0.8 m).

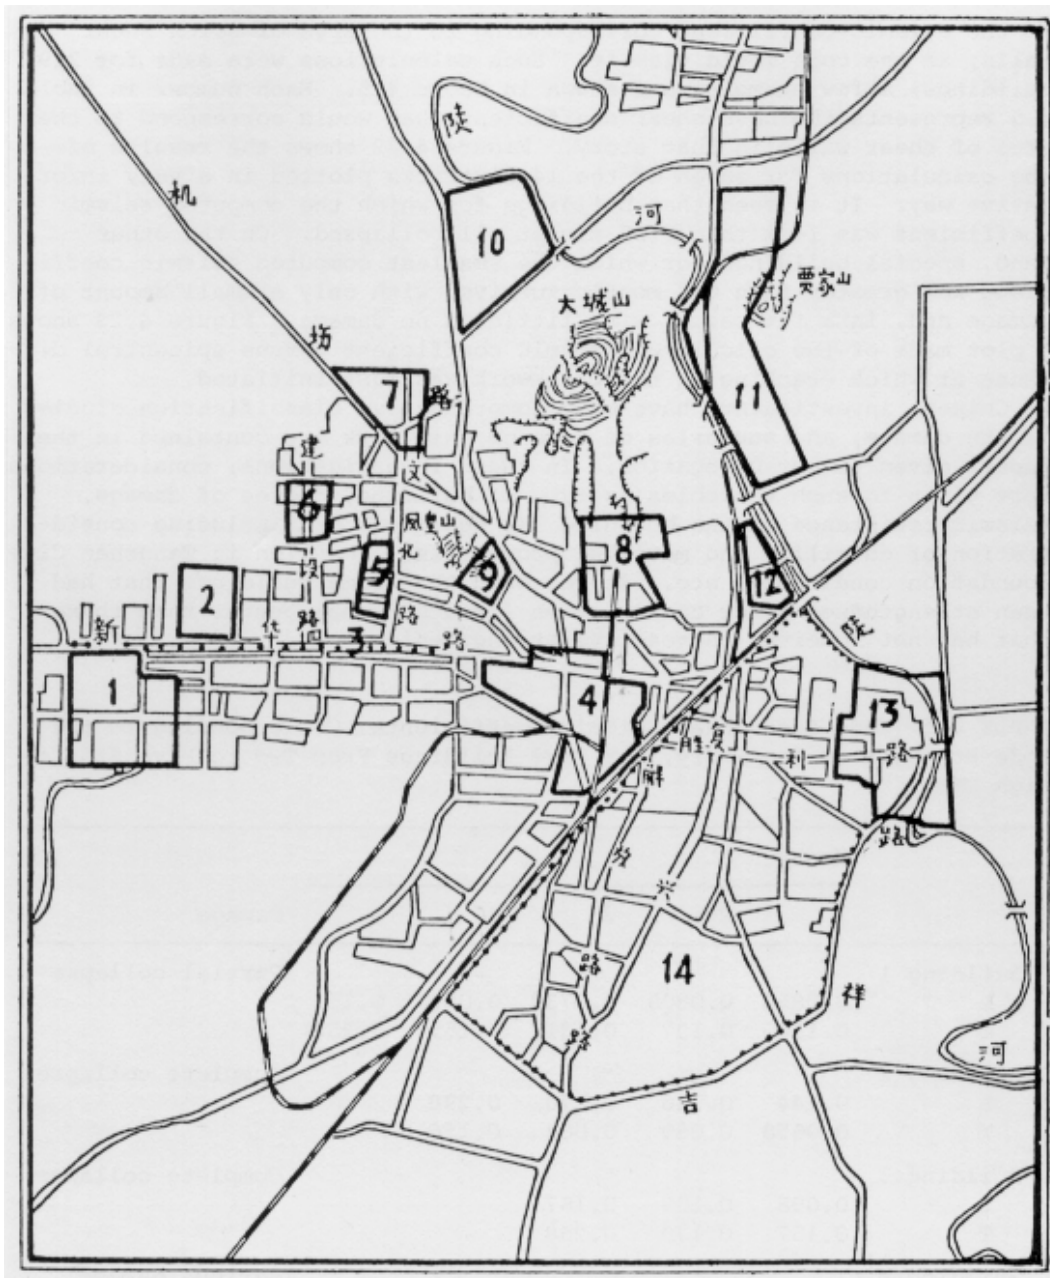
Detailed studies were made of the damage in Tangshan, and the statistics are most impressive. In one study, 14 districts in Tangshan, shown in Figure 39, were selected for detailed damage compilations. The results are shown in Table 4. There were 352 multistory brick buildings in the 14 districts and of these, 117 collapsed completely, 85 suffered partial collapse, 99 suffered severe damage, 34 sustained moderate damage, 13 sustained slight damage, and 4 received no damage at all. Approximately one third of the buildings were in these 14 districts.

Figure 39. Plan of Tangshan City showing the 14 districts in which special damage studies were made. Three hundred and fifty two multistory buildings in these 14 districts were studied; a total of 916 multistory buildings were in Tangshan. Most of these buildings were unreinforced brick structures.

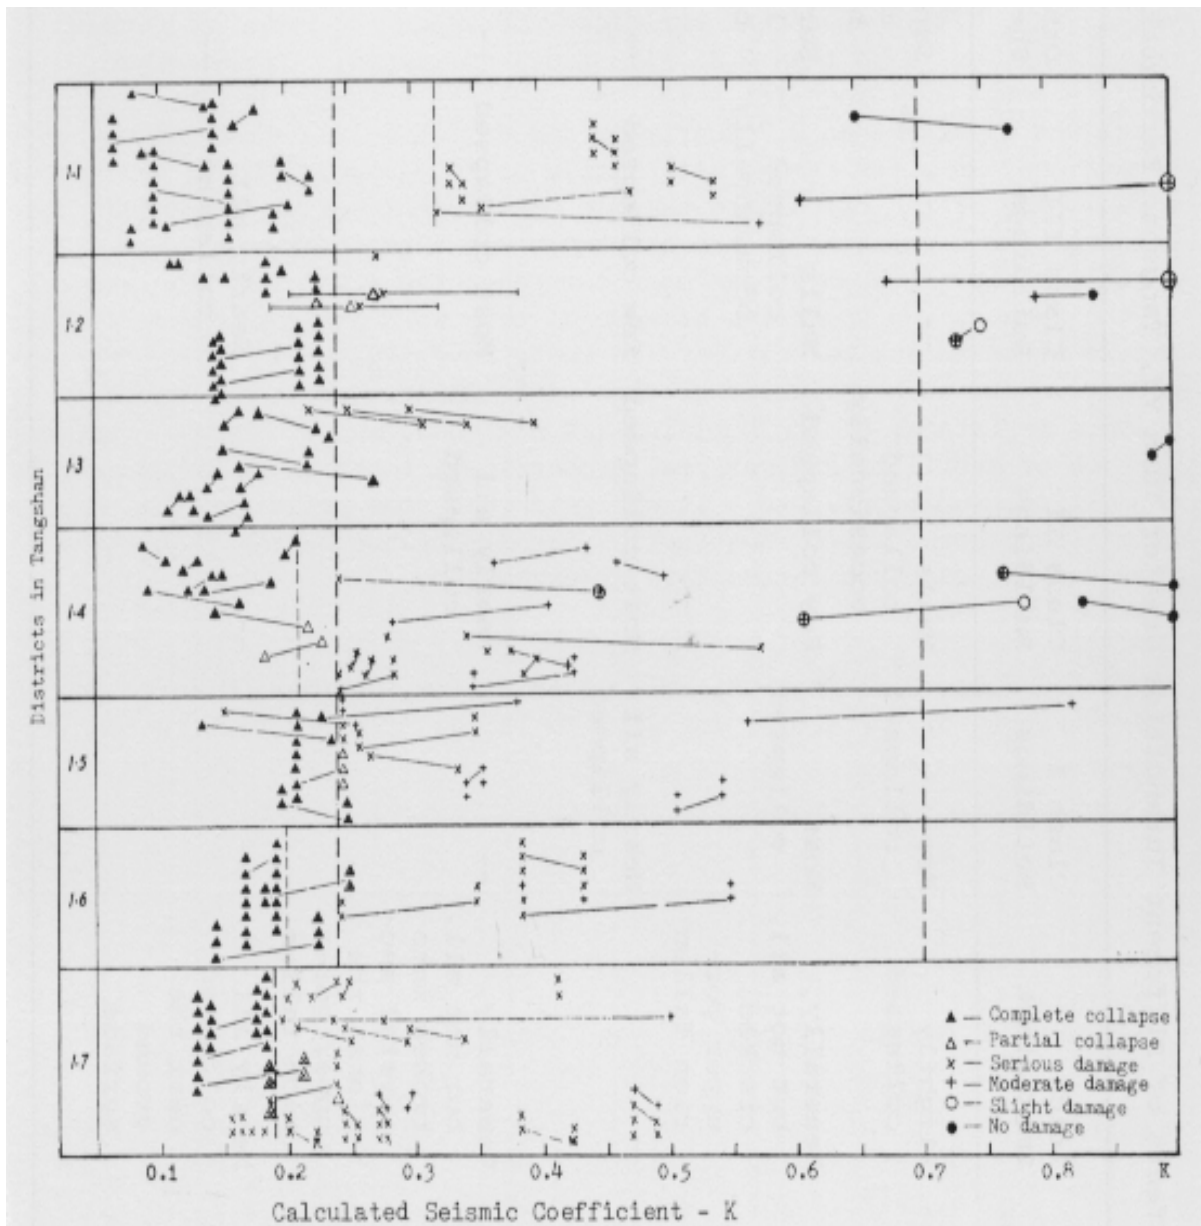
Figure 40. Plot of seismic coefficients for seven districts in Tangshan. This is a plot of calculated base-shear seismic coefficients, according to the building code, corresponding to the area of shear walls in a story. The minimum base-shear value is plotted except when only one story was damaged, and then the seismic coefficient corresponding to this story is plotted (see Table 5 and figure 39). This plot shows clearly how the nominal code strength of the building relates to the degree of damage. When the seismic coefficient was less than about 0.25, most structures collapsed; when the seismic coefficient was greater than about 0.7, the structure survived with little or damage (from Yang et al., 1978).

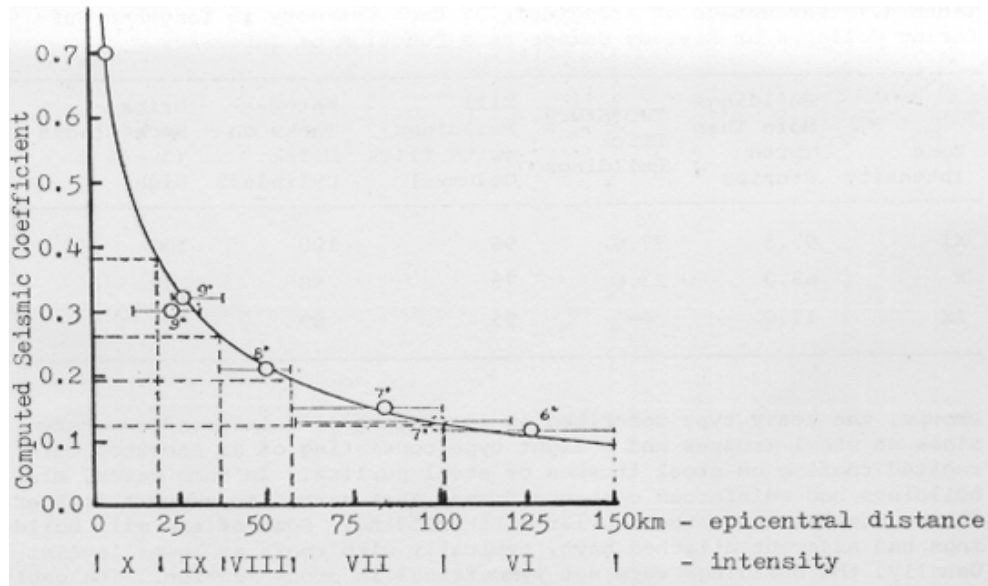
Figure 41. Plot of seismic coefficient versus intensity that produced the initial cracking, Tangshan earthquake. This is an idealized plot for the Tangshan earthquake, showing the intensity and epicentral distance at which buildings experienced initial cracking (reproduced from Yang et al., 1978).

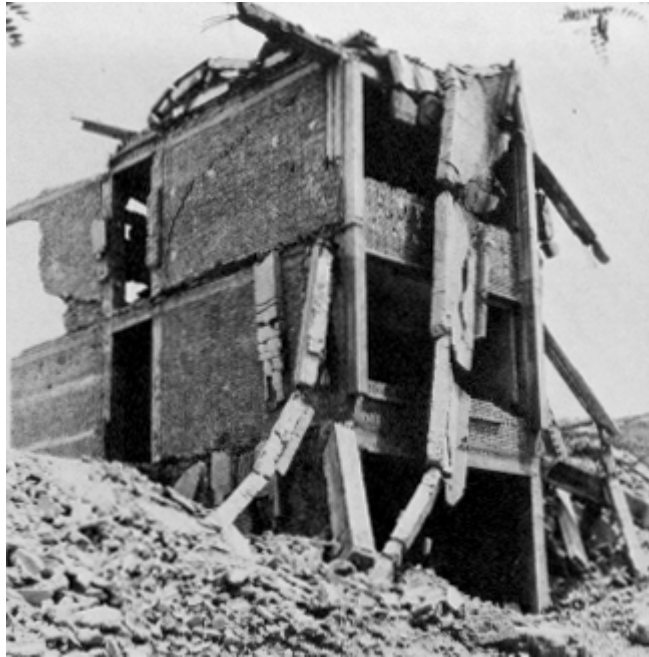
Figure 47. Collapsed five-story office building, Tangshan. The lower three stories had concrete columns, and the upper two stories were unreinforced brick without concrete columns.

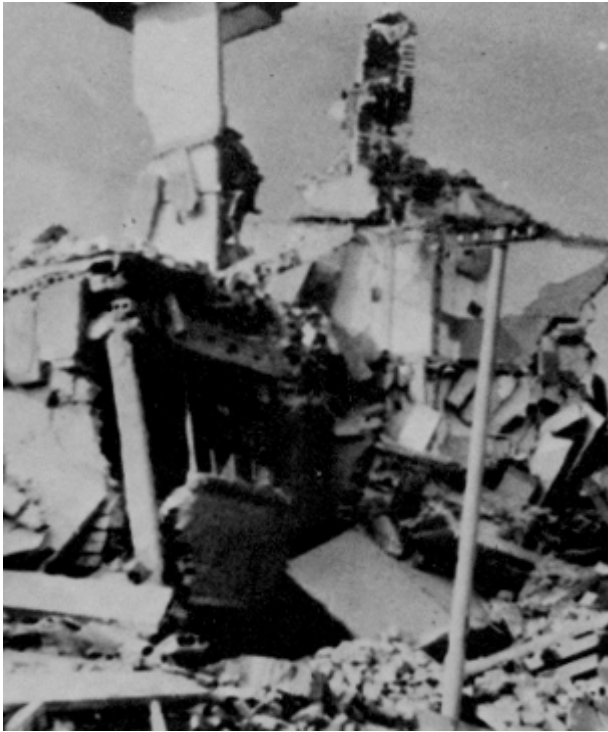
Figure 49. Collapsed building, Tangshan.

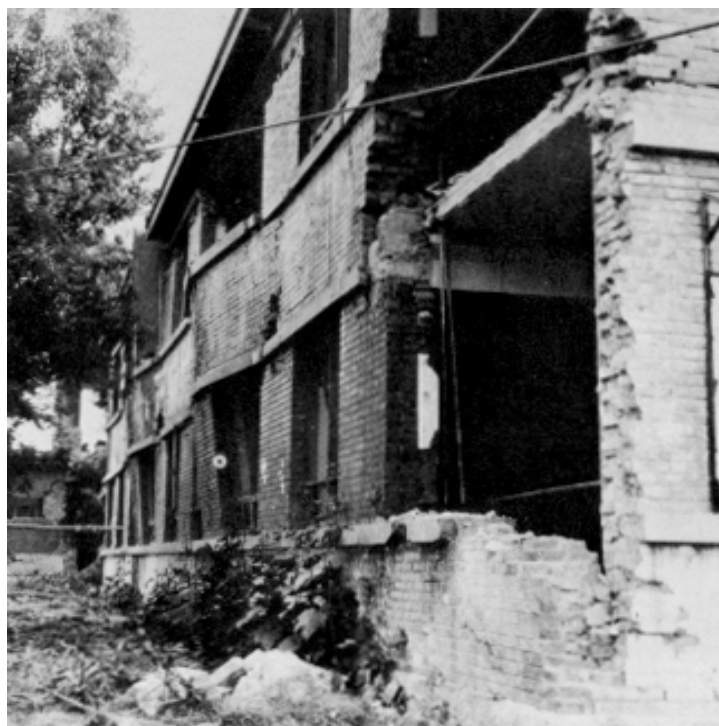
Figure 54. Badly distorted brick building on the verge of collapse. The second floor appears to be of precast concrete slabs supported on precast concrete beams, which, in turn, are supported on unreinforced brick piers.

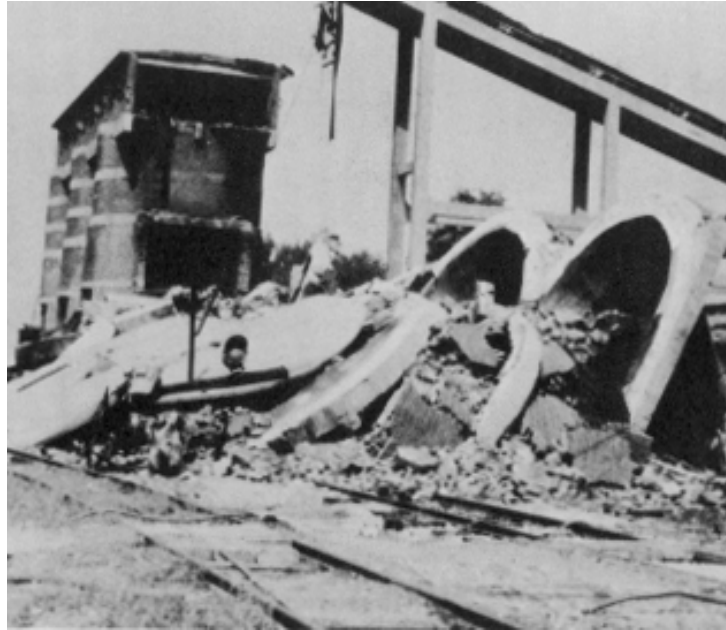
Figure 55. Collapsed brick cylindrical storage bin at the Fankechuang mine.

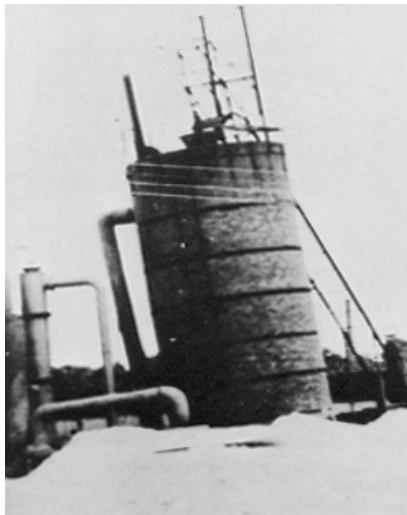
Figure 61. Tilting of a lime firing tower.

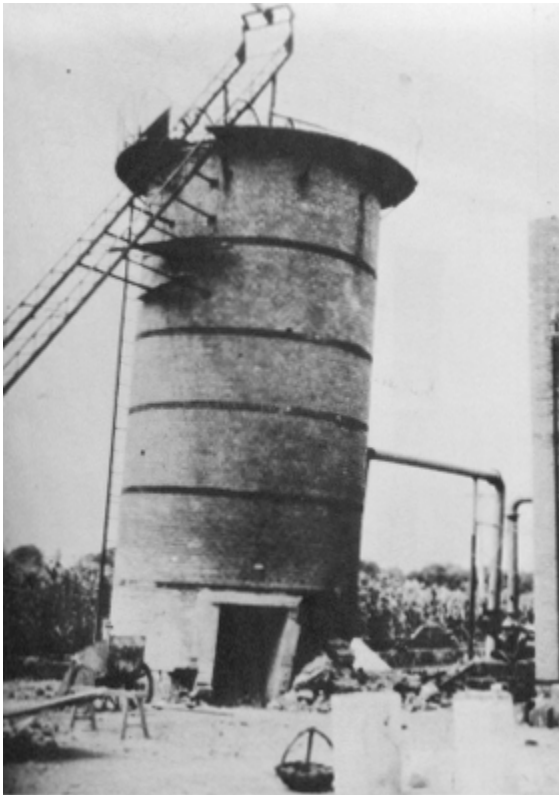
Figure 63. Tilting of brick cylindrical storage bin.

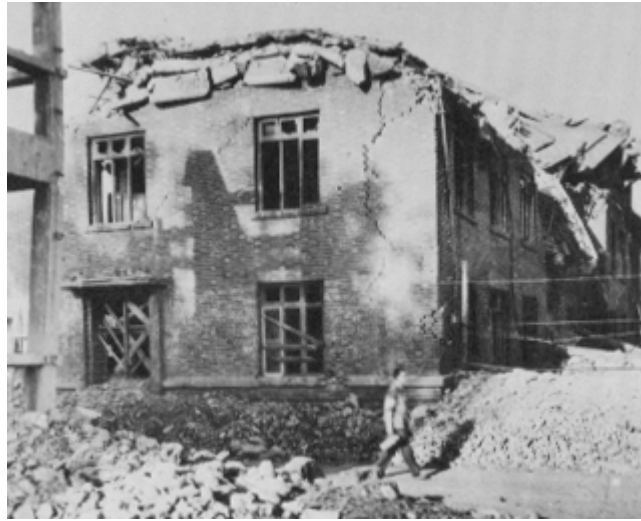
Figure 64. Partly collapsed five-story building at Coal Mine Design Institute in Tangshan.
